NEA/CSNI/R(2002)22

**NUCLEAR ENERGY AGENCY
COMMITTEE ON THE SAFETY OF NUCLEAR INSTALLATIONS**

**LESSONS LEARNED FROM HIGH MAGNITUDE EARTHQUAKE
WITH RESPECT TO NUCLEAR CODES AND STANDARDS**

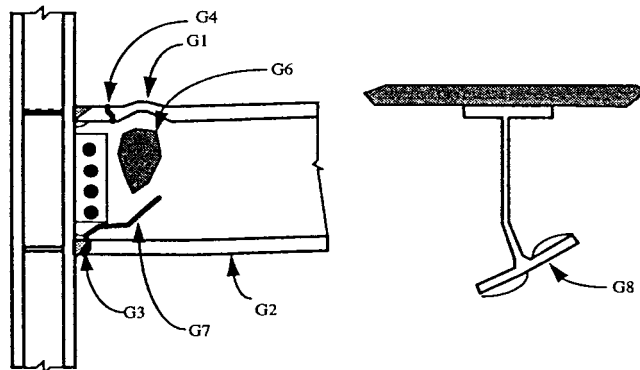
Figure 2-2 - Types of Girder Damage

Note: condition G5 consists of types G3 and/or G4 damage occurring at both the top and bottom flanges.

Type	Description
G1	Buckled flange (top or bottom)
G2	Yielded flange (top or bottom)
G3	Flange fracture in HAZ (top or bottom)
G4	Flange fracture outside HAZ (top or bottom)
G5	Flange fracture top and bottom
G6	Yielding or buckling of web
G7	Fracture of web
G8	Lateral torsional buckling of section

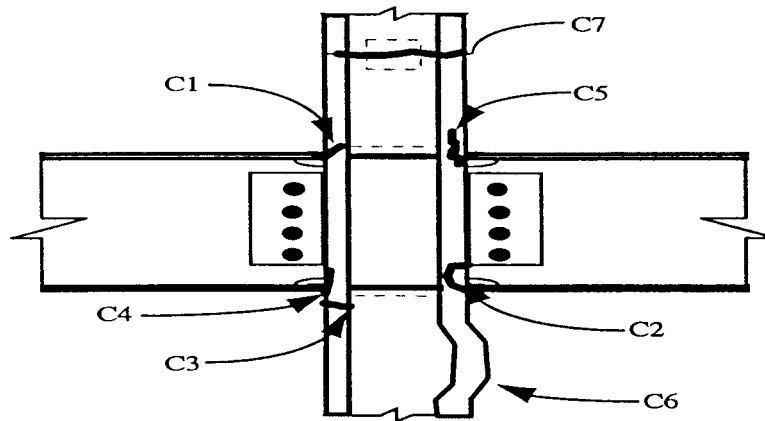
Figure 2-3 - Types of Column Damage

Type	Description
C1	Incipient flange crack
C2	Flange tear-out or divot
C3	Full or partial flange crack outside HAZ
C4	Full or partial flange in HAZ
C5	Lamellar flange tearing
C6	Buckled flange
C7	Column Splice Failure

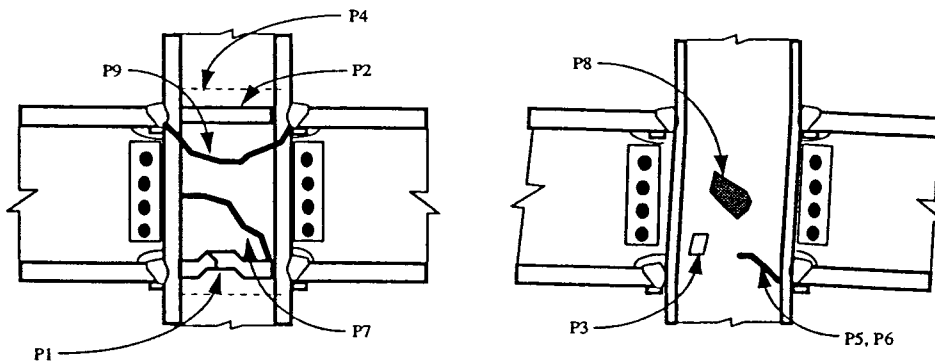
Figure 2-4 - Types of Panel Zone Damage

Type	Description
P1	Fracture, buckle or yield of continuity plate
P2	Fracture in continuity plate welds
P3	Yielding or ductile deformation of web
P4	Fracture of doubler plate welds
P5	Partial depth fracture in doubler plate
P6	Partial depth fracture in web
P7	Full or near depth fracture in web or doubler
P8	Web buckling
P9	Severed column

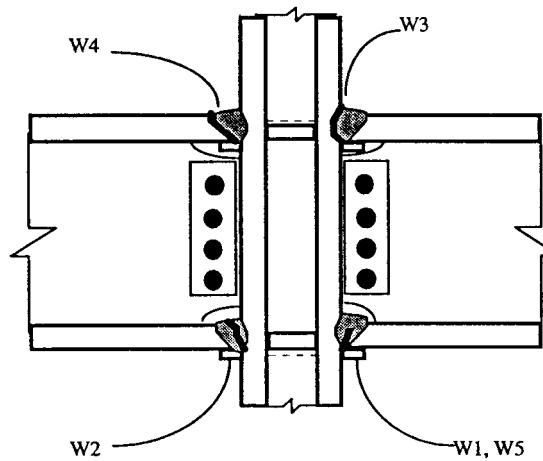
Figure 2-5 - Types of Weld Damage

Type	Description
W1	Weld root indications
W2	Crack through weld metal thickness
W3	Fracture at column interface
W4	Fracture at girder flange interface
W5	UT detectable indication - non-rejectable

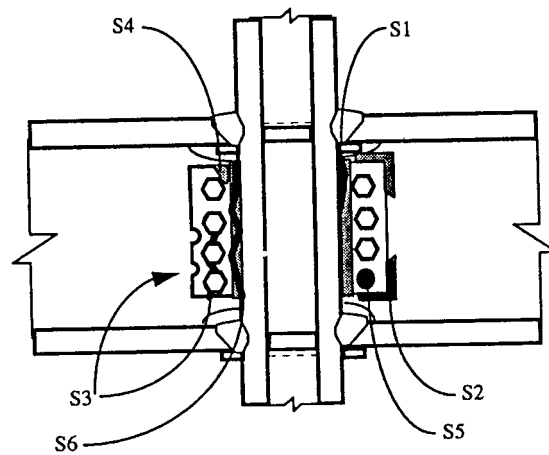
Figure 2-6 - Types of Shear Tab Damage

Type	Description
S1	Partial crack at weld to column
S2	Fracture of supplemental weld
S3	Fracture through tab at bolts or severe distortion
S4	Yielding or buckling of tab
S5	Loose, damaged or missing bolt
S6	Full length fracture of weld to column

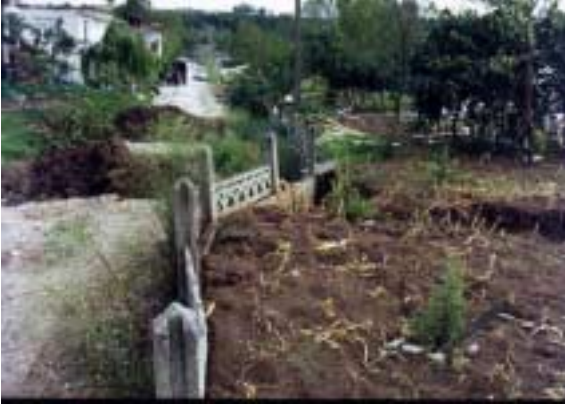
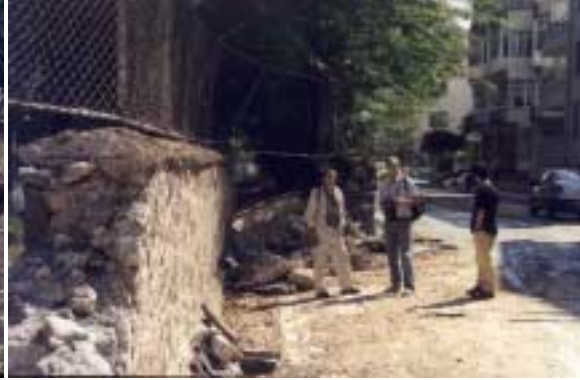
Surface faulting permanent displacements

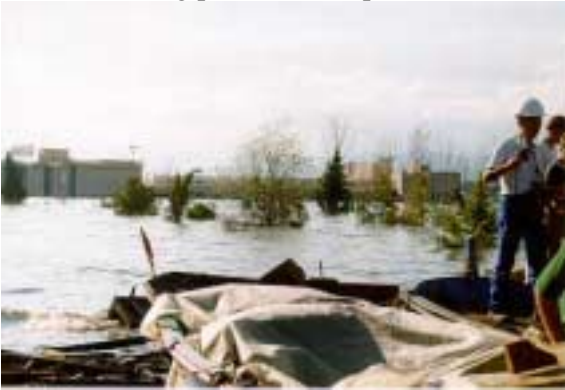
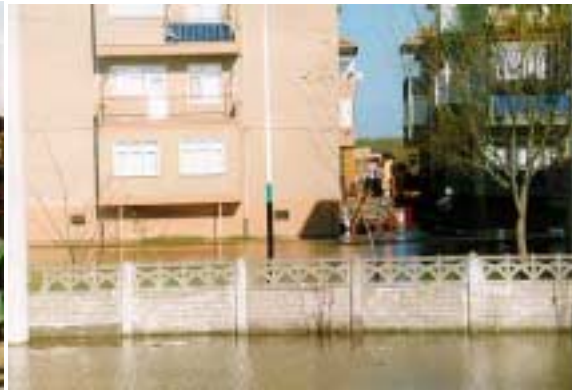
Submersed areas along Izmit bay

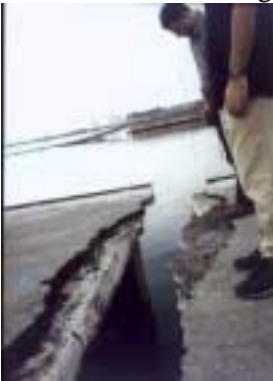
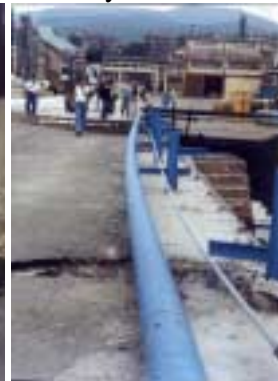
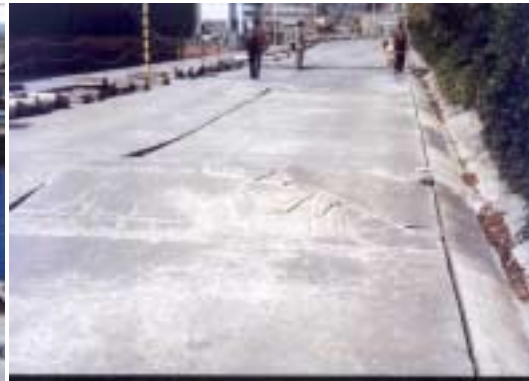
Damage to waterfront piers

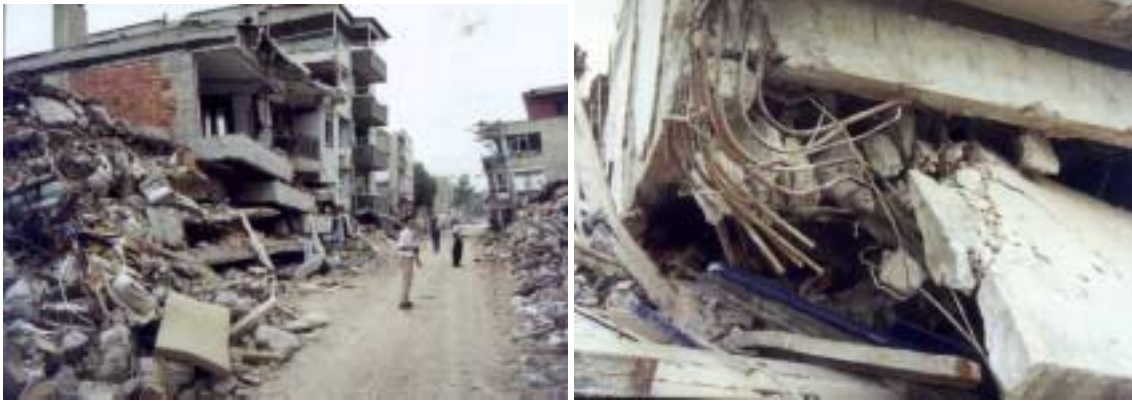
Extensive damage to buildings in Adapazari (left), poorly confined reinforcement (right)

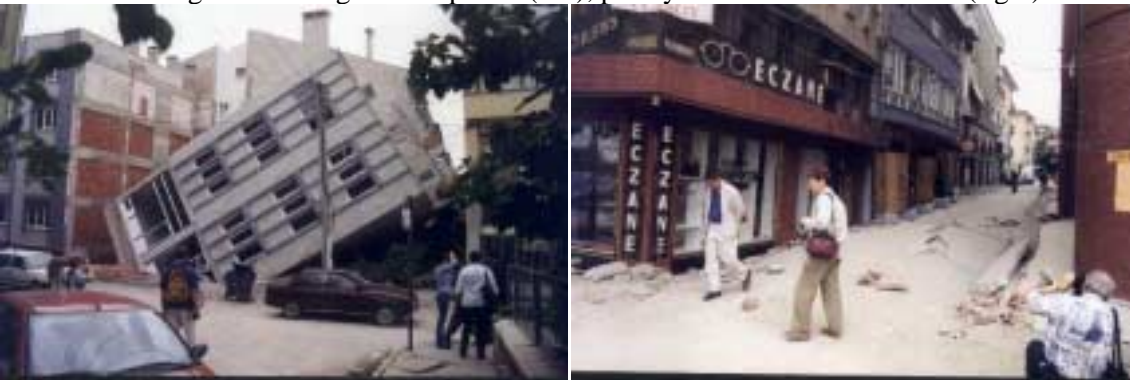
Typical liquefaction effects : overturned building (left), settlement of buildings (right)

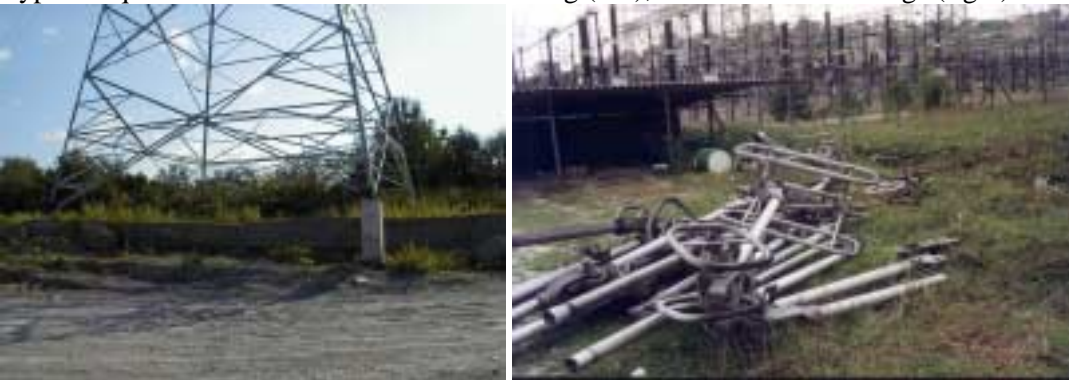
Rugged high voltage pylon (left), damage to electrical network (right)

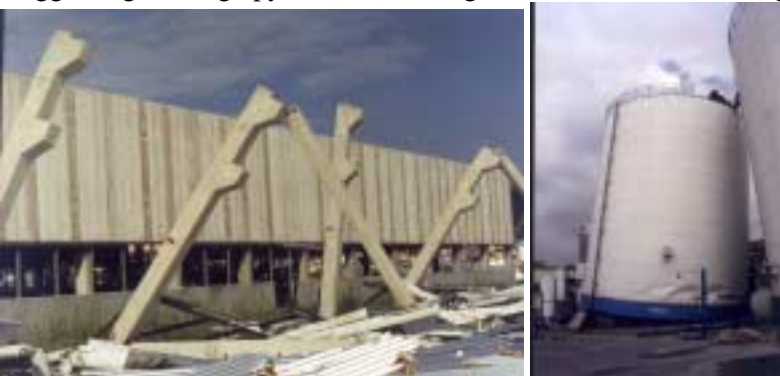
Typical precast concrete, poorly tied warehouse (left), damaged oxygen silos supports (right)

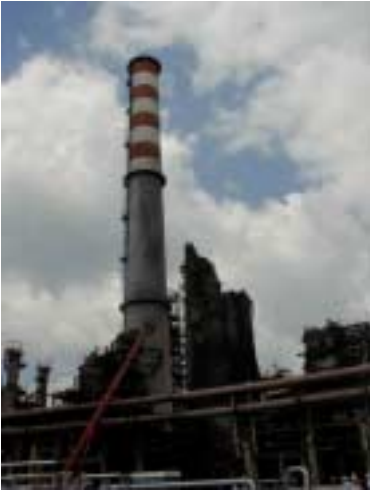
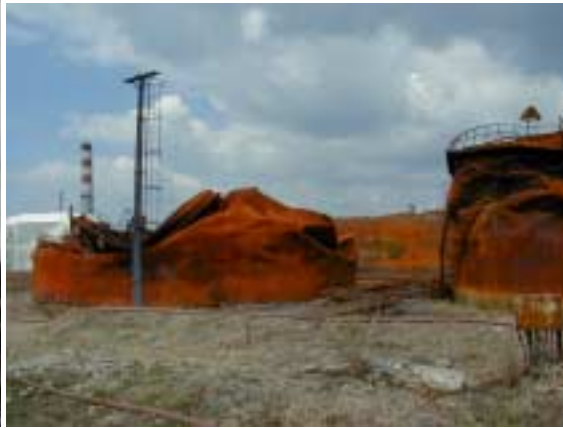
TUPRAS refinery broken chimney (left), burned and collapsed tanks (right)

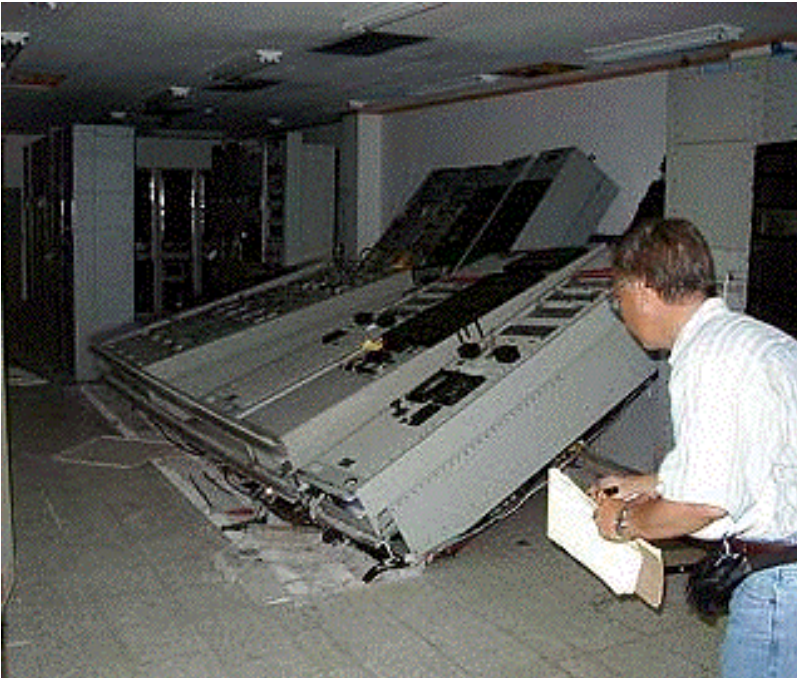
Of special interest are the failures on electricity systems: Several 345 kV transmission towers failed due to ground instabilities at exposed positions. In the switch gears, damage on 53 transformers, on 46 lightning protectors, on many ceramic insulator columns, bushings, buses, and on other installations are reported. As an example, Figure 2 shows the failure of protective panels.

Figure 2 Toppled protective panels in the main control building of the 345 kV Chungliao substation near the epicenter of the earthquake [3]
