## The EBR-II X447 high-temperature U-10Zr metal alloy experiment

**W.J. Carmack, D.L. Porter, S.L. Hayes**

Idaho National Laboratory  
Idaho Falls, ID, United States

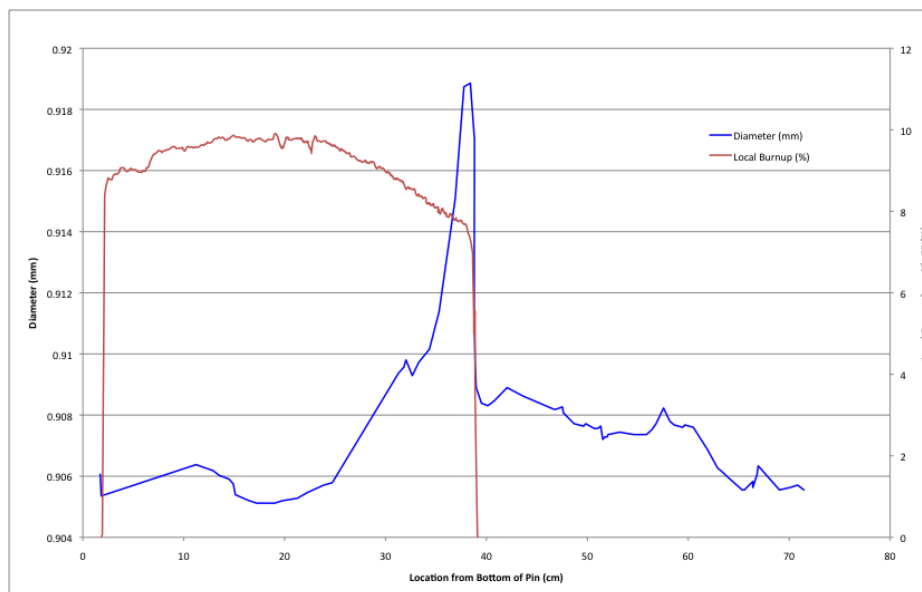
**Figure 1: Comparison of cladding dilation with fuel column burn-up for X447 pin DP-04**
