Nuclear Power Plant Operating Experience

from the IAEA/NEA
International Reporting System
for Operating Experience

2012–2014

INTERNATIONAL ATOMIC ENERGY AGENCY
VIENNA, 2018

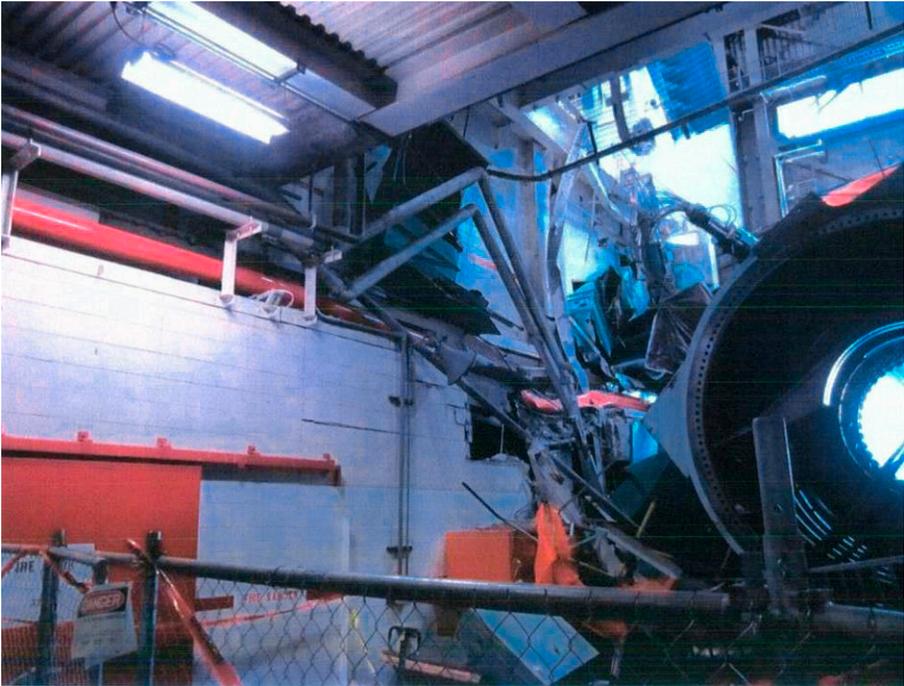
The safety significant event took place at a two unit site. Unit 1 was shut down, cooled down and about one week into a refuelling outage. Unit 2 was operating at 100% power with no technical specification limitations in effect. One of Unit 1's outage activities involved the replacement of the main generator stator. The plant operator hired a contractor to lead this activity, and the main contractor subcontracted another company to carry out the project's heavy lift operation. The temporary heavy lift assembly being used for the main generator stator replacement collapsed while lifting the stator. The main generator stator weighed approximately 500 t (500 10³ kg). One contract worker was killed and several others were injured as a result of the collapse. The impact of the stator drop was felt throughout both plants. Substantial damage was sustained by electrical switch gear and mechanical equipment located on the level below the turbine deck. The complications caused by the stator drop and related equipment damage included the following:

In the event described at the beginning of this section, while a stator was lifted for replacement, the temporary crane that was being used collapsed, and the stator fell. The dropped stator created a lot of debris before coming to rest on the hauler in the train bay (Fig. 2). Licensee staff had not checked the adequacy of the temporary crane before starting the job and instead relied on the contractor's statement that this equipment had been used previously to lift a load of the same weight. A design problem with the temporary crane was therefore missed. The investigation of the event revealed several industrial safety violations by the licensee and the contractors, as well as deficiencies in contractor supervision by the licensee.

FIG. 2. Dropped stator (partially shown on the right).

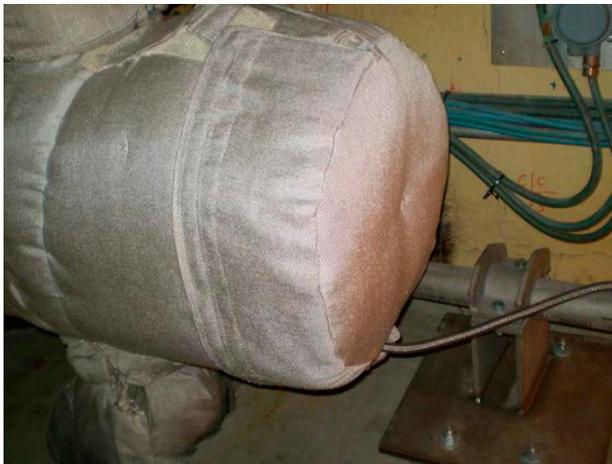
FIG. 3. Improper insulation installation.

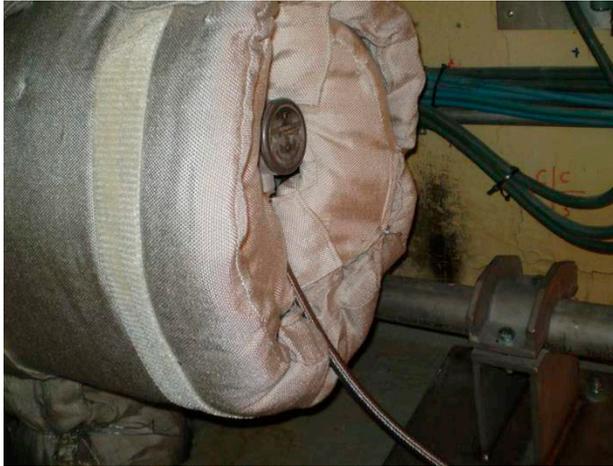
FIG. 4. Proper insulation installation.

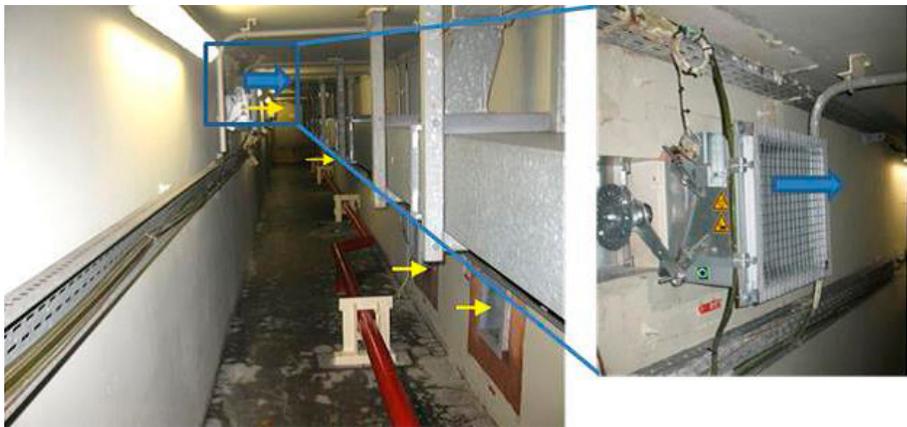
In another event, a failure in the sewage system control circuits led to an internal flood in the room housing the fuel oil tank pumps and caused prolonged unavailability (i.e. more than one day) of one of the diesel generators. Another internal flood was caused by the rupture of a rubber bellow in a diesel generator cooling pipe. An error in the design pressure of the bellow technical specification was the cause of the bellow failure. The flood could have spread to different rooms because the plant flood safety analysis had not included the case of a double guillotine break in low energy piping, according to applicable standards (only a limited leak rate). As a result, the room's sump volume and draining capacity were insufficient (see Fig. 5).

FIG. 5. Examples of internal flooding.

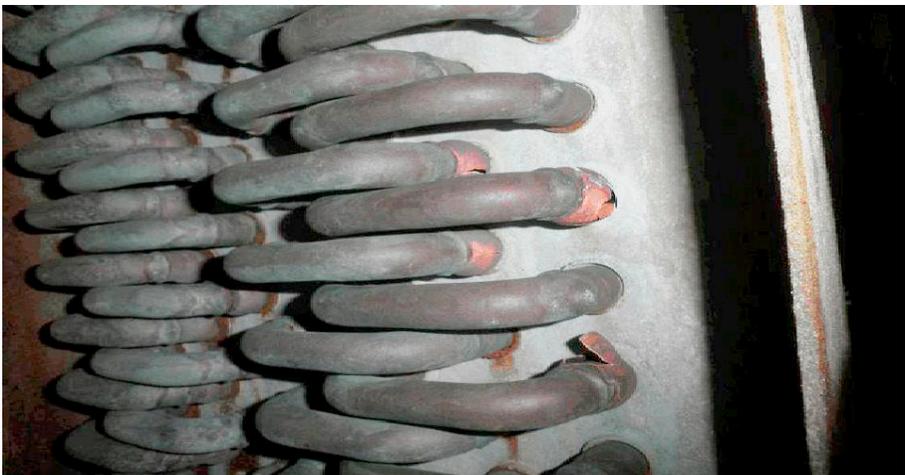
A leak from the heat exchanger tubes (Fig. 7) in a hot water system required to maintain building temperatures could have led to loss of the reactor coolant system's boron make-up function if not dealt with quickly.

FIG. 7. Heat exchanger tubes, showing origin of leak.

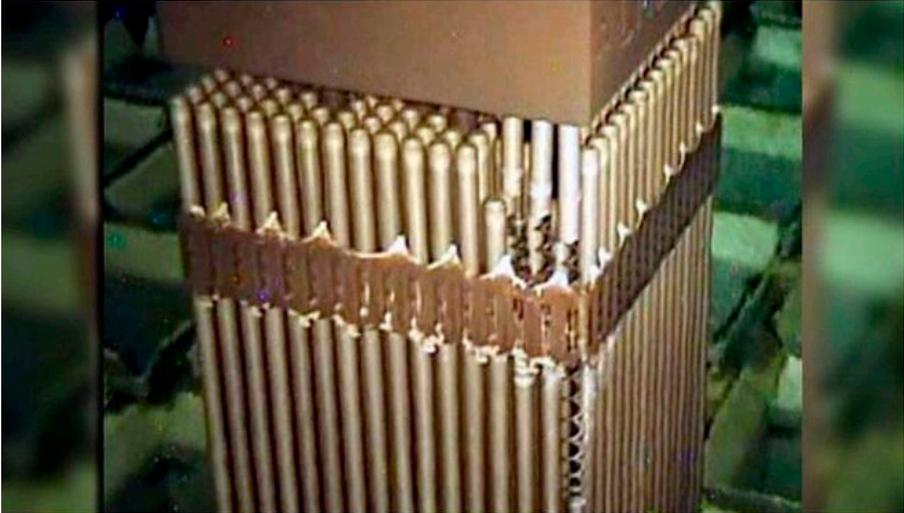
A review of events reported during the 2012–2014 period identified recent occurrences of a previously well known fuel failure mechanism that was first identified in 1971. This phenomenon is called baffle jetting, and this fuel failure mechanism can occur in pressurized water reactors that use core bypass flow to cool the baffle area during operation. In reactors with a downward flow scheme, a portion of the coolant from the reactor inlet flows through a hole in the upper portion of the core barrel into the space between the outside of the baffle plates and the core barrel (this flow is part of what is known as bypass flow). Reactor coolant that is not bypass flow goes down through the annulus and then changes direction to go up through the core support and lower plate and then through the core. The different flow paths and the associated pressure drops between the two can create a differential pressure between these fluids. If enough of an area or gap exists between adjacent baffle plates, and the pressure difference between the core flow and bypass flow is high enough, a high pressure water jet can form between gaps in the baffle plates. This phenomenon is called baffle jetting, and the water jet that is created can impinge on nearby fuel assemblies and result in cladding perforation and a potential for the loss of fuel pellets and other fuel rod components into the reactor coolant, spent fuel pool and other associated systems (see Fig. 9).

FIG. 9. Fuel damage / baffle jetting.
