First Construction Experience Synthesis Report 2008–2011

Working Group on the Regulation
of New Reactors (WGRNR)

NEA/CNRA/R(2012)2

**First Construction Experience Synthesis Report
2008-2011**

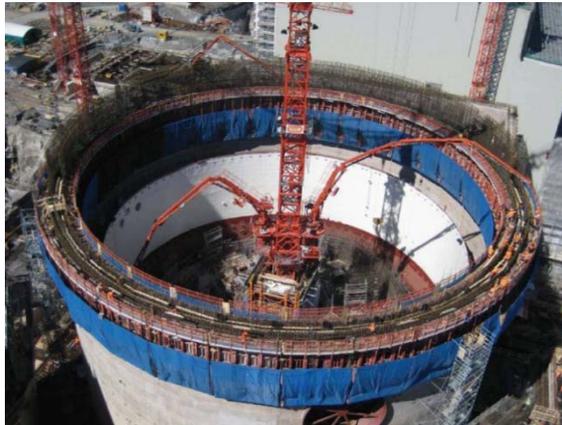
In Olkiluoto-3 in June 2007 following welding of the steel liner some imperfections were detected that exceeded the acceptance criteria.

The direct cause of the poor quality of the welding was the change in the welding environment (wetting of the concreted area nearby causing extra humidity) and human error of the welders.

- Inadequate management of the welding environment (increased and unacceptable humidity during welding due to wetting of the concrete surface).
- Incorrect pre-job briefing to understand the safety significance of the welding process.
- Incompatibility of the liner parts not adequately taken into account in the fit up and welding of the liner.
- Inadequate control of the welders and welding quality during the welding process.

The licensee corrected the deficiency by replacing parts of the liner by new steel plates (sized at 0.5 m² average).

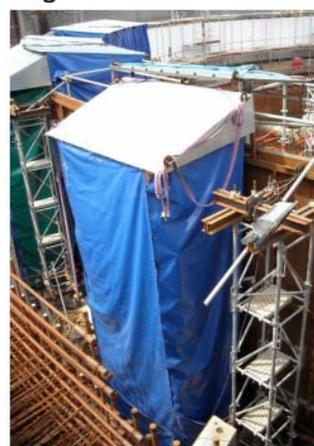
In June 2008 at Flamanville-3 the licensee, after several questions raised by ASN about the welding activities on the liner, decided to stop all welding activities. That same month an inspection by ASN found that the welding processes used were not permitted by the construction code. ASN required a justification for the lack of compliance with the construction code to ensure the quality of the liner in such conditions.

In the following months ASN detected an excessive number of repairs (especially on the reactor building basemat area), they found inadequate consideration of adverse environmental conditions (water, wind, etc.), and required the licensee to demonstrate the quality of the liner welds and to define preventive actions to reduce the repair or rework rate of welds. As a response to this, the licensee submitted a report that concluded that the defects were due to gas cavity, inclusion, and only 4% of the defects due to lack of fusion, wormhole, etc. It also indicated that the repair rate in the reactor basemat area was between 13% to 34% while this same figure in the prefabrication area was between 5% and 15%.

The direct cause of these events was poor manual welding, worsened due to the bad weather conditions. The automatic process was not possible in the environmental conditions of the building site.

The safety consequence of these deficiencies in the liner welds was the loss of the pressure boundary of the containment.

The main actions taken by the licensee were to develop suitable protection of the welding areas to improve the environmental conditions, reinforcing the control of its subcontractors and performing a 100% radiographic test of the liner welds.

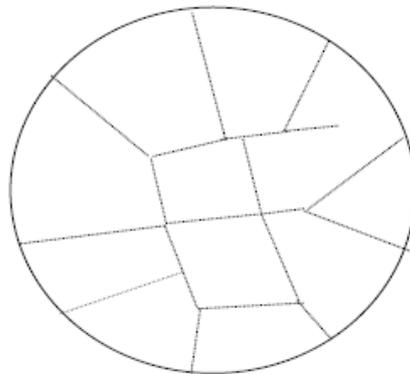
Configuration of cracks in the circular basemat

In Flamanville-3 in January 2008 the licensee reported to the ASN the appearance of cracks in the poured concrete basemat of the reactor building. The transverse cracks ran the full depth of the first layer for the reactor building basemat (1.75m - 4200 m²). The biggest cracks were 3.5 mm wide, but as time went on, the licensee observed that the width of the cracks were decreasing. The pouring activities of the second layer of the basemat were deferred by the licensee to wait for the conclusions of the assessment performed by ASN and IRSN on this non-conformity.

The direct cause was the lack of steelwork reinforcement at the level where pouring was stopped.

The main safety consequence of this deficiency is the impact on the mechanical strength of the basemat.

Immediately after the discovery of the deficiency, the licensee treated the cracks by filling them with epoxy resin under pressure to protect the exposed steelwork and close ground water paths. Also, the licensee demonstrated to the ASN that by applying this resin there would be no loss of mechanical strength and that the basemat would be leak tight against underground water.

As a preventive action, the licensee has adopted the appropriate pouring strategy (i.e. improving the concrete formulation) to minimize cracks.

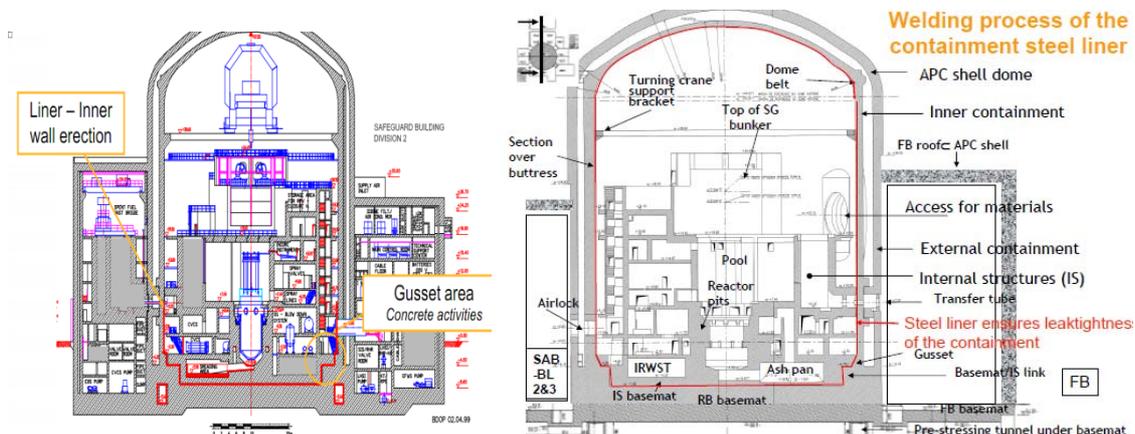
In October 2008 the licensee’s procedure for the concrete pouring of the gusset area considered two concreting lifts without joint treatment. The installation of the steel reinforcement of the gusset area without the joint treatment is not in compliance with the construction code ETC-C.

The safety consequence of this deficiency is a potential loss of the mechanical strength of the gusset and also a loss of the leak tightness of the barrier.

According to the ASN, the root cause of this event was the lack of preparedness and planning of the licensee and its contractors to perform safety-related activities.

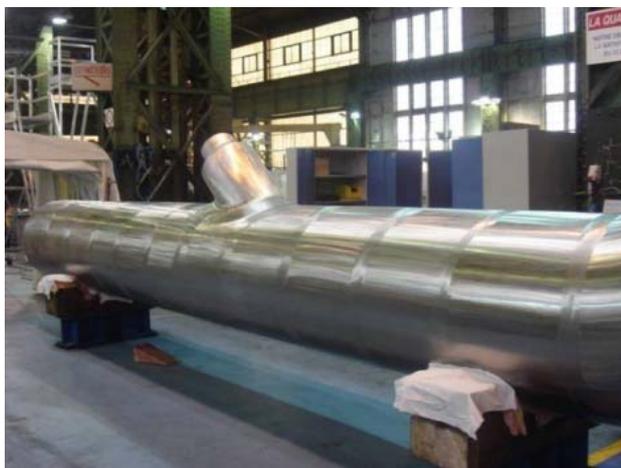
- *Inhomogeneous grain size*

In Olkiluoto-3 the main coolant lines (Hot and Cold Legs) of the primary circuit are manufactured from large forgings to minimize the number of welds. Tests performed on the main coolant line forgings revealed coarse and inhomogeneous grain size areas in the forgings. In addition, tensile and hot tensile strength values were somewhat too low for some forgings. Grain size exceeded the criterion which was specified in the Preliminary Safety Analysis Report (PSAR).

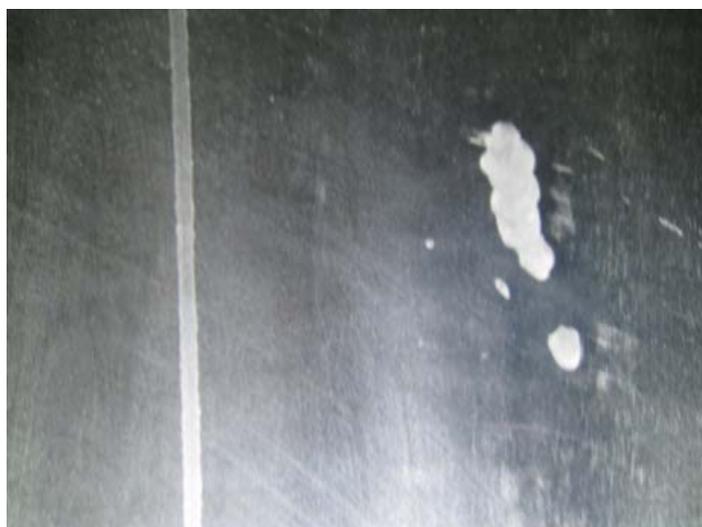
Hot leg weld root and a base material weld repair.

VT after pipe pickling revealed small non-documented welds on the MCL inner and outer surfaces at off-site manufacturer Fives Nordon. Non-documented welds were found on 10 out of 12 pipes with weld depths of 0-5 mm.

The reason for making the welds had been a habit to finalize small scratches and dents by welding and to re-melt MMA weld toes using a TIG welding process. TIG welding and the filler metals used were qualified for nozzles welding, but the repair welding was done without documentation (violation of RCC-M S 7120 and S 7600) and without non-conformance reporting controls. Many of these weld repairs could have been omitted, if designers would have evaluated the right repair method for each case. The company engineering and quality assurance units were probably not fully aware how the practical work was going on at the shop floor level.

Technical NCRs were opened and the welds' properties were evaluated using VT, PT, UT, RT, PMI (chemical analysis) and metallographic replicas. Most of the weld properties were acceptable for use. Some welds had peculiarities like increased copper content and they were ground off. None of the repair welds were located on highly loaded areas of the pipes, such as close to the nozzles, where thermal

Causes for the deficiencies were lack of communication between fabrication and design departments, inadequate education of welders (welding without specification and documentation), and failures in the implementation of the quality management system. These causes reflect a lack in the implementation of a nuclear safety culture.

The repair welds are not located at highly stressed areas. Pipe internal repair welds are not considered likely to have an effect on component ageing. Pipe external repair welds are considered insignificant.

fluctuations are present during operation. Some welds were removed using smooth grinding while the majority were left in the products as-is. New repairs were not needed.

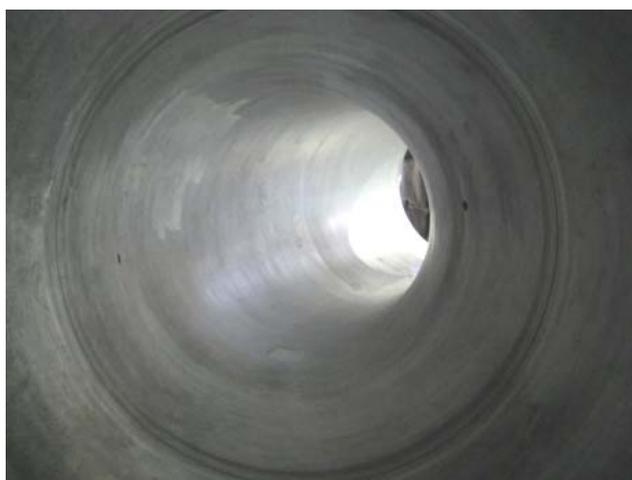
Hot leg bend.

Inside surfaces of induction bent main coolant line areas showed circumferential VT and PT indications after pickling right before delivery to the site. The majority of the indications were found more than a year after the induction bending and where the result of the bending process. Qualification of the induction bending process had not been completely successful and the quality of the post-bending PT tests was poor in revealing material discontinuities. Contrary to the RCC-M code, sand blasting had been used immediately before PT testing and it obviously smeared the metal surface ruining the PT testing performance.

The majority of the indications had successfully gone through two previous VT and PT tests associated with the bending process. The possibility of common cause for the indications had not been properly evaluated when some material discontinuities were found soon after bending.

Direct causes have not yet been properly evaluated by the vendor/sub-contractor. However, material discontinuities have obviously formed when at elevated temperature during induction bending. The two possible theories for the formation mechanism are: 1) metal folding or 2) grain boundary cracking.

An indirect cause was that the qualification of the induction bending process failed to identify the possibility of the development of these material discontinuities. Preparation for PT testing was unacceptably done using sand blasting, which resulted in hiding the indications and improper evaluation of the qualification pieces. Further, even if some indications were found at Mannesmann soon after bending, an enhanced test program was not started and the common cause was not properly evaluated.

Extra PT and VT were conducted by the vendor and indications that were found were repaired by grinding.

Extra NDT testing for surface opening and buried defects of the type considered was required to be made before system pressure test at the plant. This action was required to get proof of the vendor/licensee claim of the good performance of the previous extra PT and VT results.

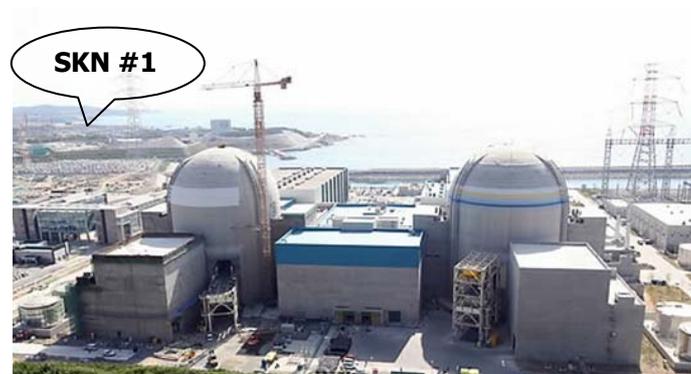
Shin-Kori Unit 1, was licensed by the Korean Government (Ministry of Education, Science and Technology) on May 19, 2010. Under a power raising test to 50% of full power, it was manually shutdown on September 14, 2010 to re-adjust the ex-core detector position. After completion of the maintenance on the ex-core detector, the plant restarted the power raising test, controlling the reactor coolant temperature utilizing the shutdown cooling system. The plant was in mode 4 with the RCS pressure and temperature at 28kg/cm^2 and 145°C , respectively. Both the shutdown cooling system and the containment spray system share the shutdown heat exchanger and are separated by the heat exchanger outlet isolation valve (CS-V033) and the containment spray isolation valve (CS-V035). CS-V033 was opened and CS-V035 was closed when the incident happened.

On September 17, at 14:17, CS-V035 opened inadvertently due to human error, and reactor coolant was sprayed into the containment through the containment spray system. The RCS experienced a severe transient; the pressure decreased rapidly from 28 kg/cm^2 to 3.9 kg/cm^2 and the temperature and water level were lowered quickly. Rapid decreases in RCS pressure and water level were identified by the MCR operators, and they carried out responsive actions in accordance with the emergency operating procedure (EOP) including stopping reactor coolant pumps (RCPs), isolation of the letdown line, and increasing the charging flow. Also, additional safety measures were taken including manual actuation of safety injection to recover the RCS inventory, and manual actuation of containment isolation to prevent any radioactive material release to the environment.

After taking a series of initial responses, the MCR operators identified that the containment spray isolation valve (CS-V035) was incorrectly in the open position and the valve was manually closed at 14:54. At this time the plant entered into a stable condition. The analyses results based on the changes of refueling water tank (RWT) level and RCS inventory showed that the amount of borated water sprayed into the containment was 423 tons.

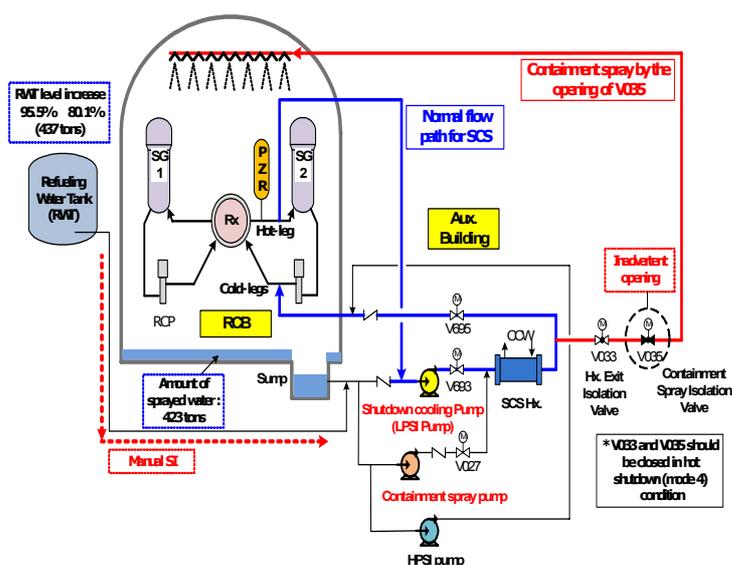
During the event, the major plant safety systems including the emergency diesel generator (EDG) and containment purge isolation were actuated as designed. As a result of the event, most of the Structures, Systems, Components (SSCs) inside the containment were affected by the sprayed borated water; especially the reactor cavity and the containment floor level were flooded.

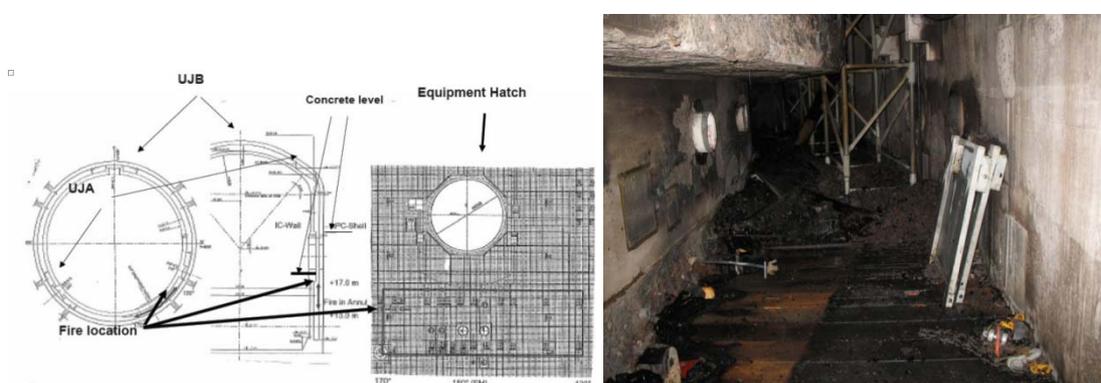
In Olkiluoto-3, on 30 July 2008 a fire initiated in the annulus space (space between the containment and reactor building wall) at level + 13 m and + 17 m, below the equipment hatch.

Initial investigations after the fire revealed damage to the concrete structures in the fire area (local spalling of protective concrete cover of reinforcement) and to the surface paint of the sleeve of the equipment hatch.

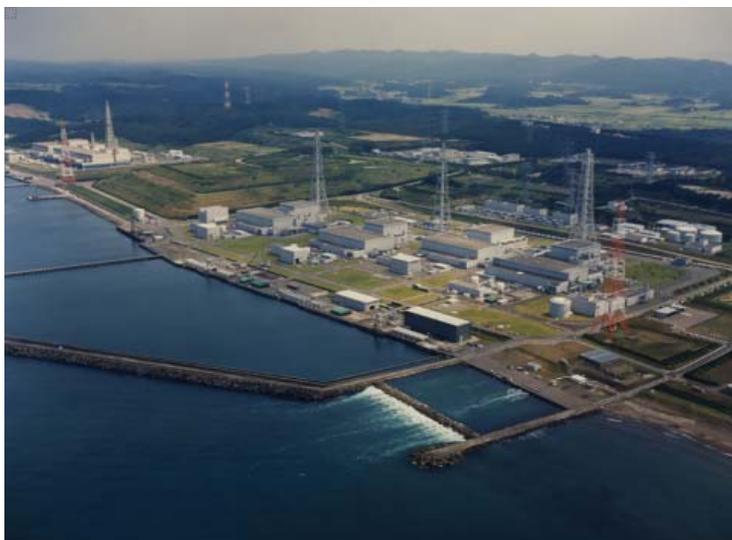
- *Event 55. Kashiwazaki-kariwa.2007.Japan.*

A seismic event of 6.8 on the Richter scale occurred 16 km from the site at 10:13 A.M. on 7/16/07. A small fire occurred in an electrical transformer in the switchyard of unit 3. It took two hours for the fire to be extinguished. About 315 gallons of radioactive contaminants leaked from Unit 6 and reached the Sea of Japan (1621 nano-curies total). The primary cause of this deficiency was determined to be an earthquake greater or comparable to SSE.
