NEA/CSNI/R(97)23

## **OPERATING AND MAINTENANCE EXPERIENCE WITH COMPUTER-BASED SYSTEMS IN NUCLEAR POWER PLANTS**

**A report by the PWG-1 Task Group on Computer-based Systems Important to Safety**

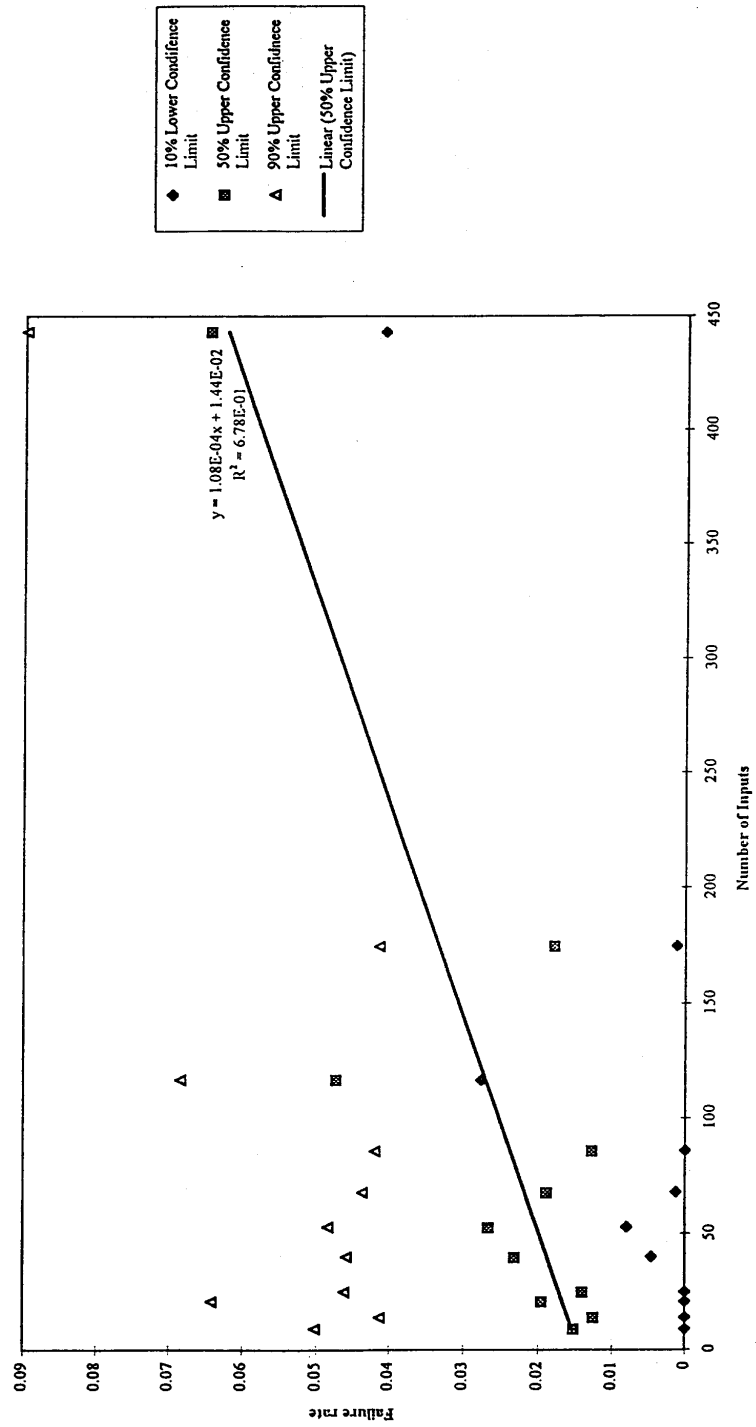
**Figure 3.1 - Relationship between Failure Rate and the Number of Inputs**

Figure 3.1 shows the relationship between failure rate and the number of inputs. It can be seen that there is a generally increasing trend but a fairly wide spread of data points from the trend line. The  $R^2$  value is 0.678.

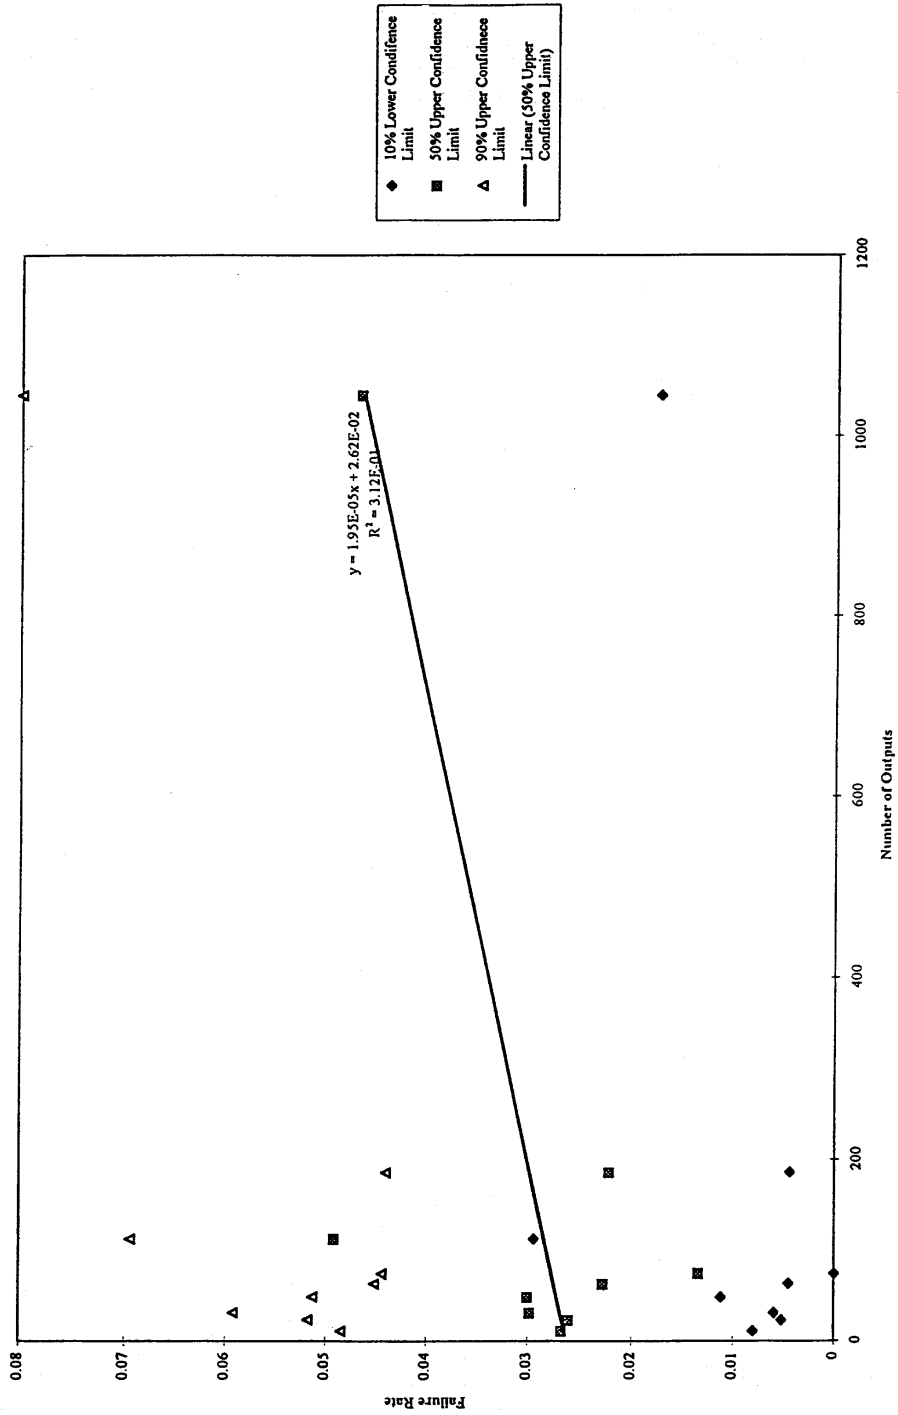
**Figure 3.2 - Relationship between Failure Rate and the Number of Outputs**

Figure 3.2 shows the relationship between failure rate and number of outputs. Although the trend line shows a gradually increasing trend, the fit is poor ( $R^2=0.312$ ).
