**NEA/CSNI/R(2002)7/VOL1**

**OECD-NEA WORKSHOP ON THE EVALUATION OF DEFECTS,  
REPAIR CRITERIA & METHODS OF REPAIR FOR CONCRETE  
STRUCTURES ON NUCLEAR POWER PLANTS**

**Hosted by GRS at the DIN Institute in Berlin, Germany**

**10th-11th April, 2002**

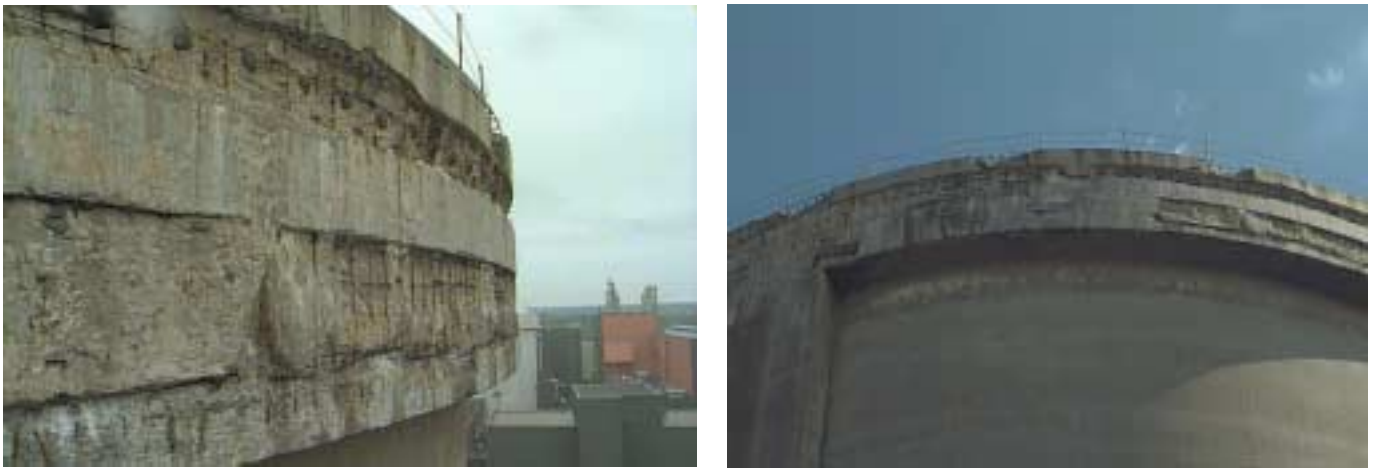
**Figure 1a, b: G-1 Ring Beam, South Side**

The Plant was designed by AECL in the late 1960'ies and became operational in 1972. In 1980, AECL decided to place the station in a lay-up state and to generate a plan for its final disposition. It was concluded in 1984 that returning the site to a condition of completely unrestricted access and usage was not immediately necessary and, for technical and financial considerations, the attainment of this objective should be delayed for the next fifty to eighty years. AECL, the owner of the facility, was required to maintain the facility in a "static state". In general, the purpose of the maintaining of the facility was to provide interim storage for all conventional and radiological hazards until the facility is finally decommissioned and demolished. Therefore, it was decided that Gentilly-1 containment structure would be required to function for more than fifty years beyond its originally expected design life. However, the structure was visibly aging in the ring beam secondary concrete area that was protecting the prestress anchorages. The poor appearance of the structure was significantly influencing perception of safety and proper functioning of the nuclear installations. The ring beam deterioration is shown in Figures 1a and 1b.

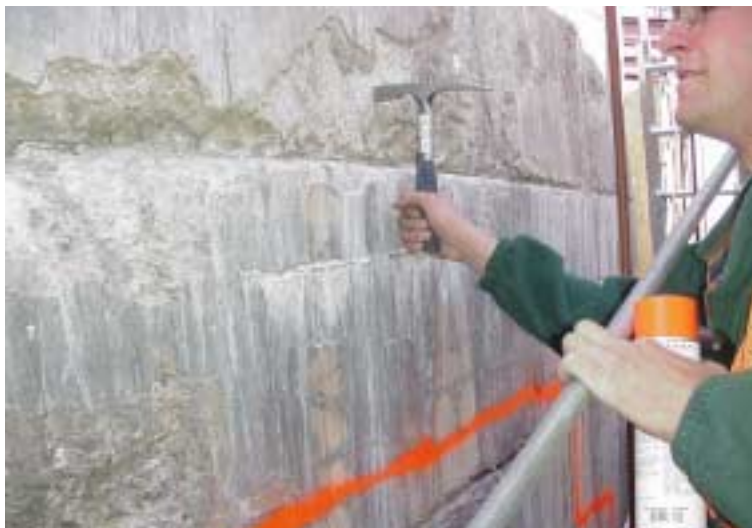
**Figure 5: Sounding the Concrete Surface**

As shown in Figure 5, using the sounding method, all of the unsound and unbonded concrete was marked, measured and prepared for demolition.

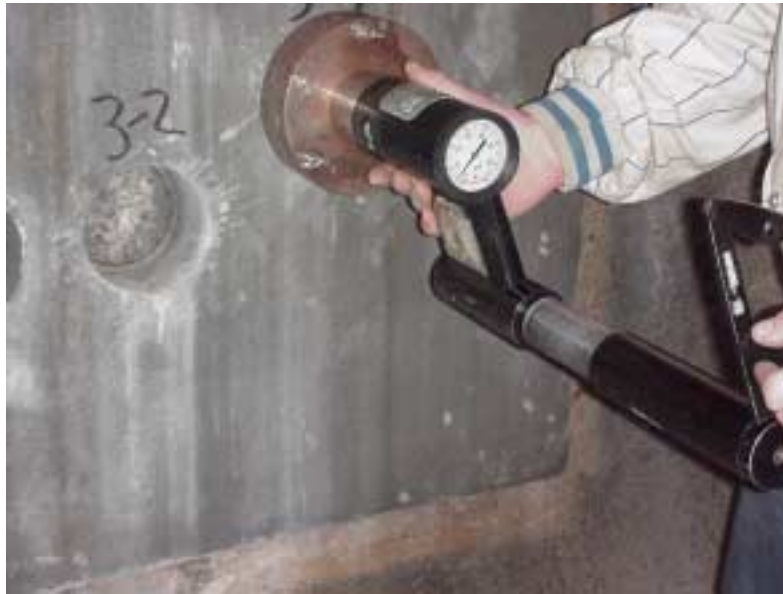
**Figure 12: Pull-out Test**

The quality workmanship and the concrete properties of the placed repairs was verified by drilling 101.6 mm diameter cores 'in situ' and performing pull-out tests as shown in Figure 12. The pullout tests gave average bond strength (repair material to old concrete) from 1.2 MPa to 2.1 MPa, which is above the revised value of 1.0 MPa required by the Specifications.

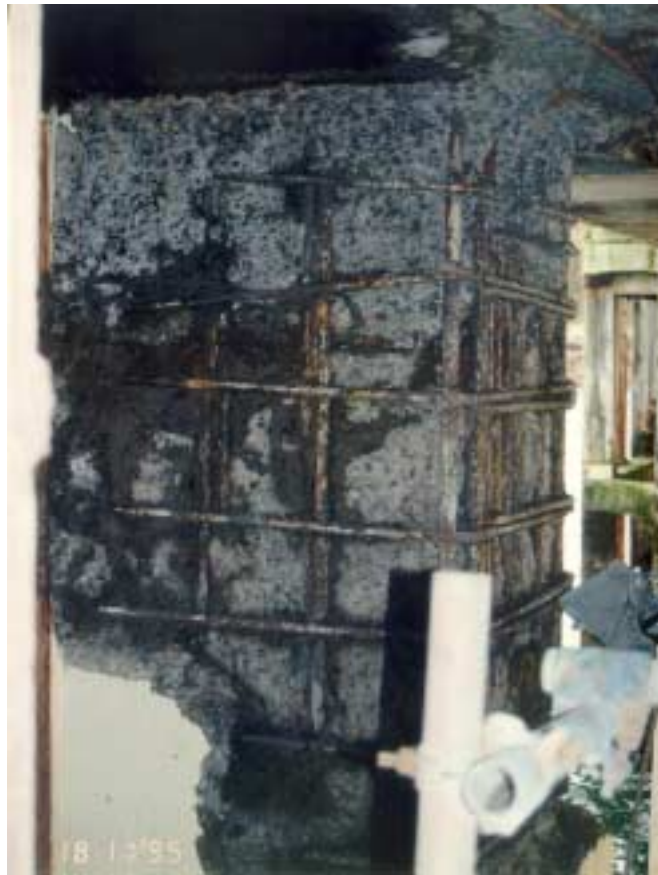
**Plate 2 Exposed steel reinforcement after removal of cover**

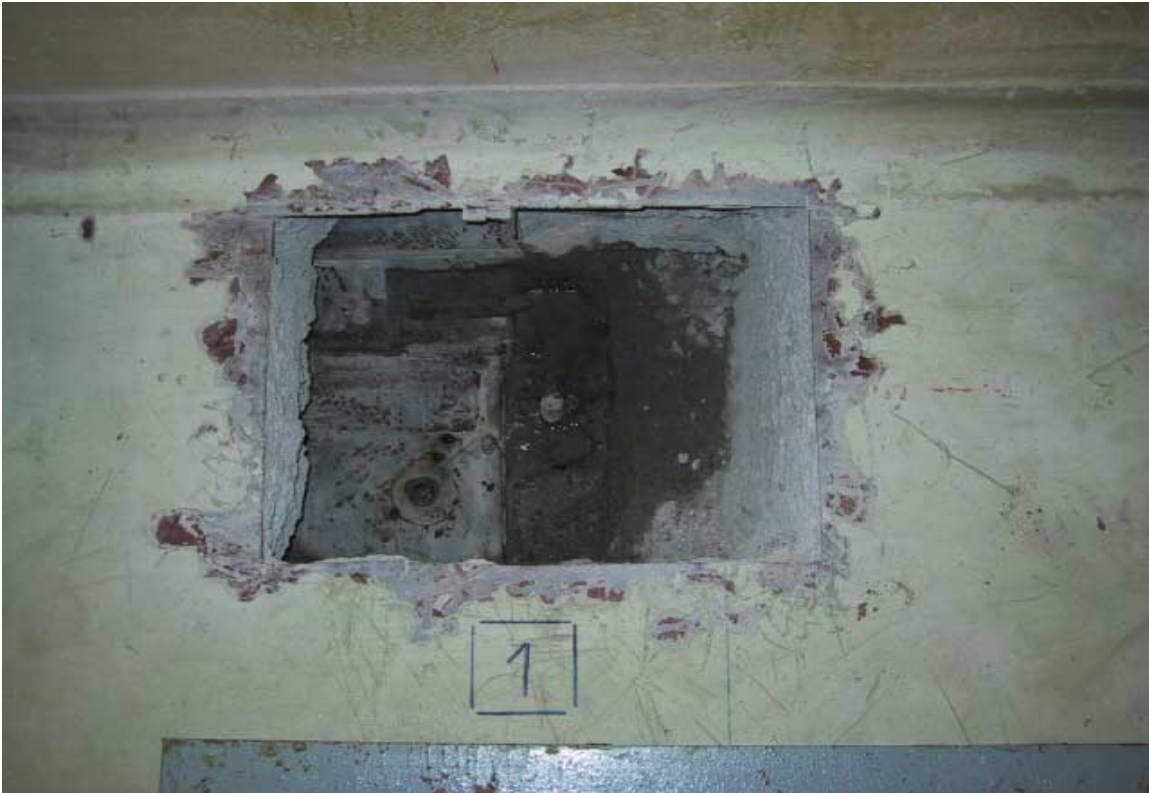
Injektion point No 1./19 deconstructed concrete in A201/1

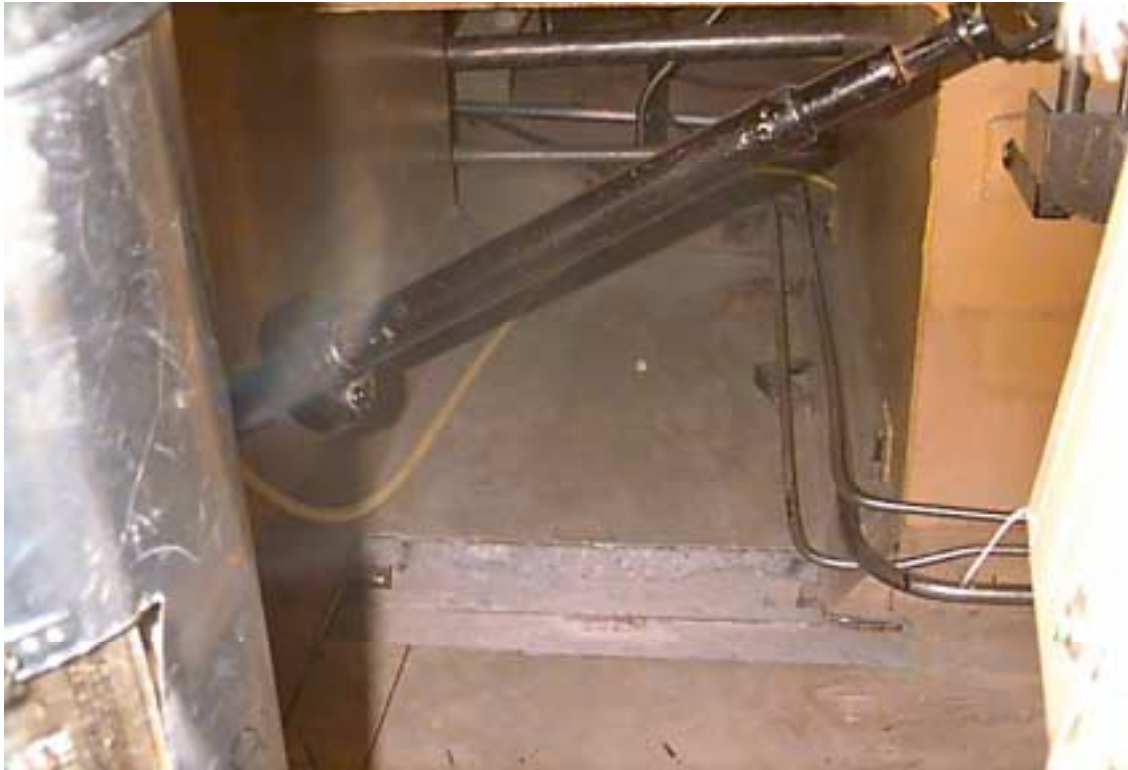
## Excavated connection to liner in room A306/1

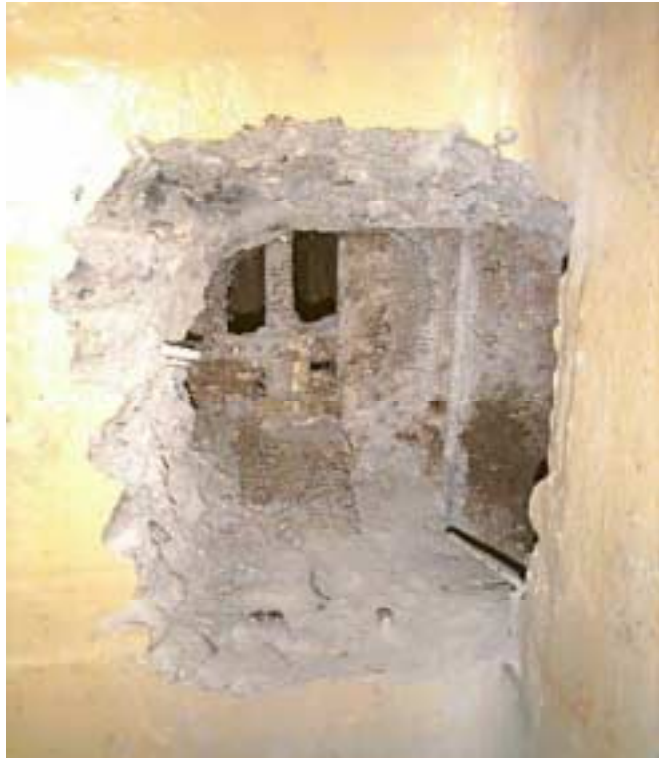
## Hole in structural concrete discovered by drilling for injektion

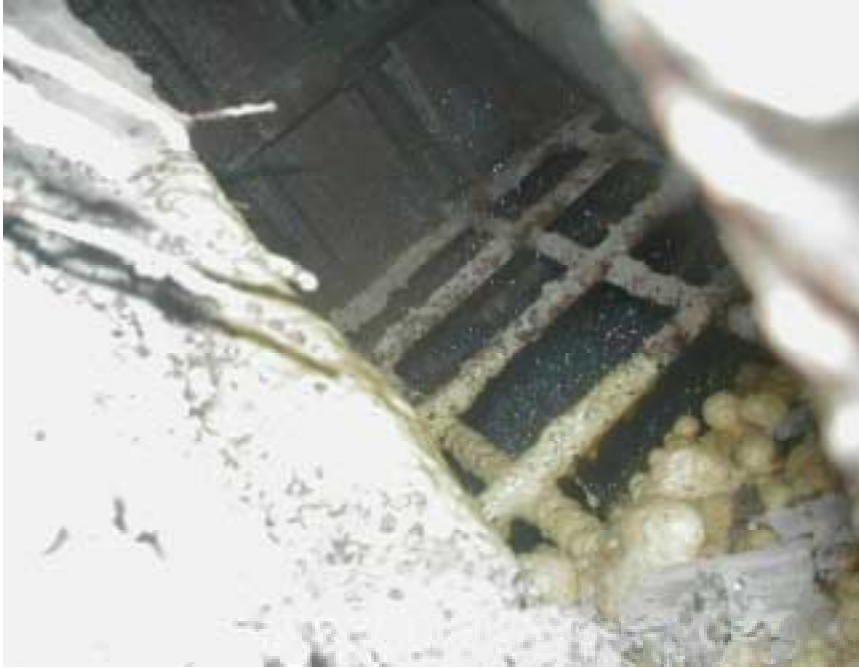
Inside of hole in structural concrete  
discovered by drilling for injektion
