NEA/CSNI/R(2002)7/VOL2

**OECD-NEA WORKSHOP ON THE EVALUATION OF DEFECTS,
REPAIR CRITERIA & METHODS OF REPAIR FOR CONCRETE
STRUCTURES ON NUCLEAR POWER PLANTS**

Hosted by GRS at the DIN Institute in Berlin, Germany

10th-11th April, 2002

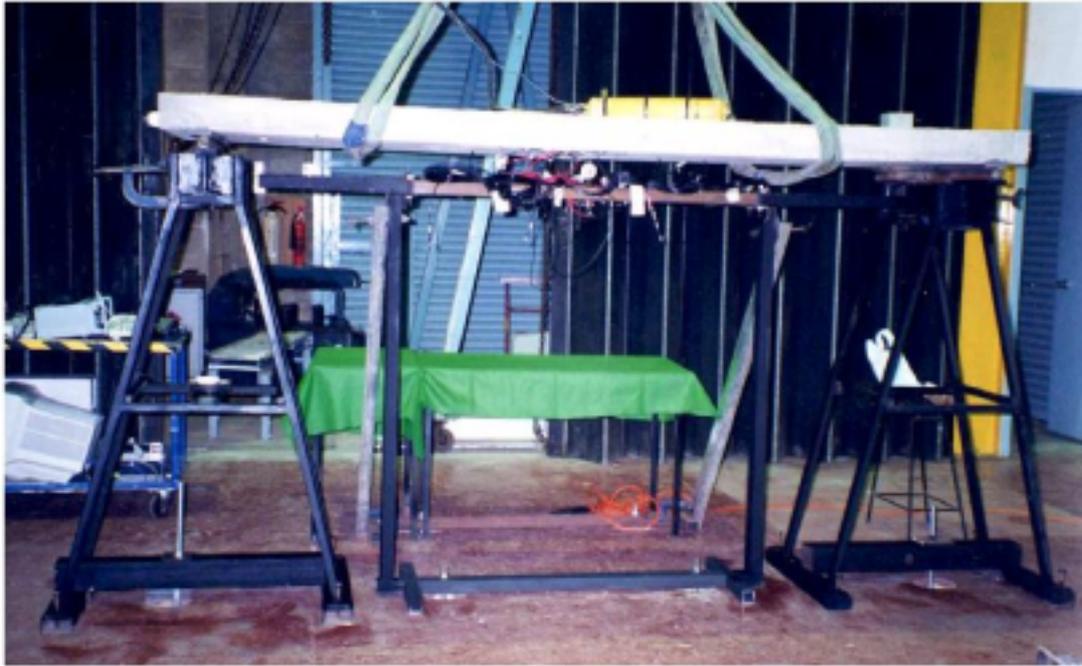
Plate 1 General layout and set-up of the instrumentation employed on beam for stage 2

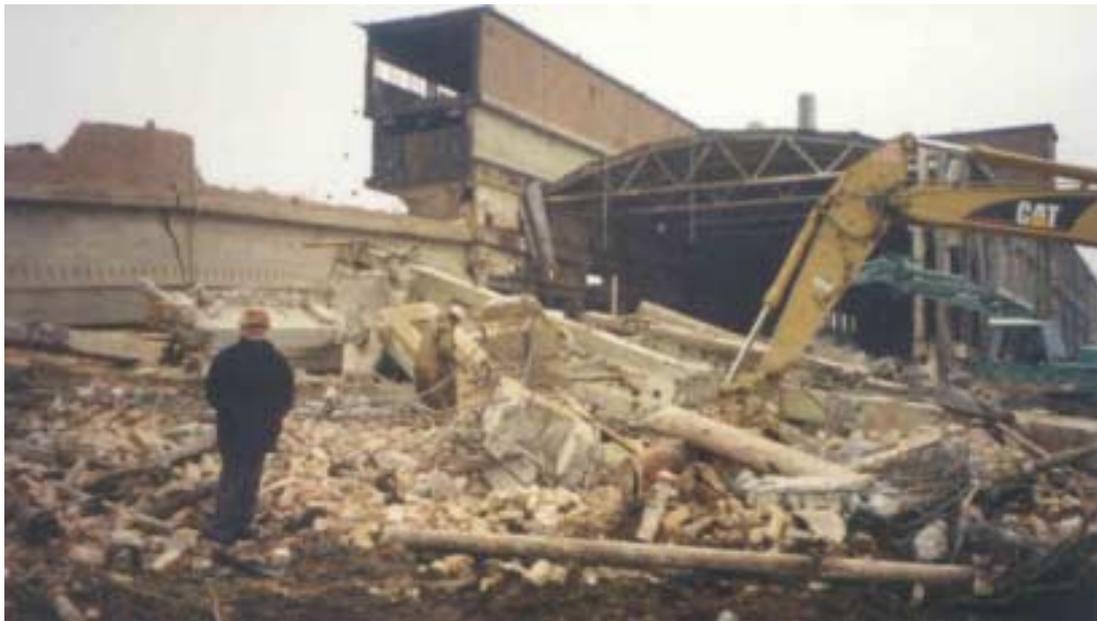
After 40 years of service the uranium ore mining was terminated and the hall was demolished (Fig. 2).

Fig. 2 The partly demolished hall

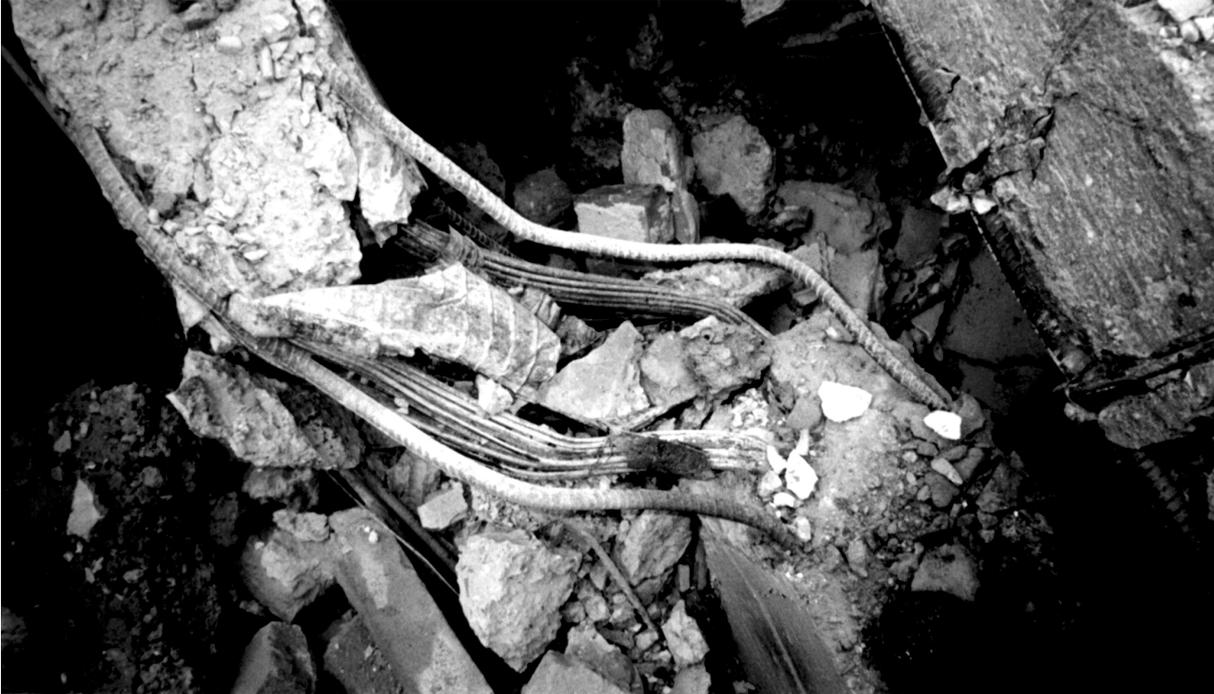
Likewise after the demolition parts of the prestressed bottom chord of the truss were surveyed and neither on the prestressed wires, nor on the other reinforcement traces of corrosion could be find (Fig. 4).

Fig. 4 Surface of prestressing wires and rebar

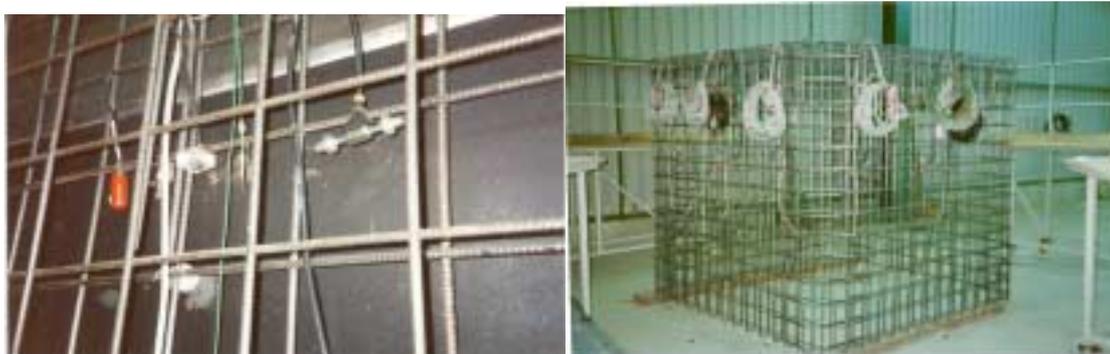
A particular example of the use of embedded sensors is the case of storage facilities of low and medium radioactive wastes in El Cabril (Córdoba)⁷. There, a pilot container has been instrumented from 1995 by embedding 27 set of electrodes (Figure 3). The parameters controlled are: temperature, concrete deformation, corrosion potential, resistivity, oxygen availability and corrosion rate. The impact of temperature on several of the parameters is remarkable, and therefore, care has to be taken when interpreting on-site results.

Figure 3: Preparation of the embedded sensors in El Cabril

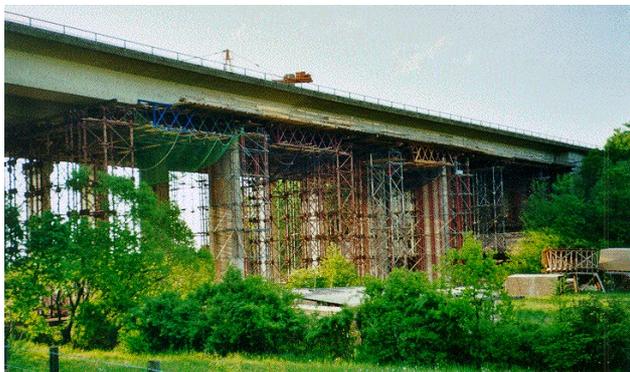
Fig. 6 Investigation of a 150 long bridge with a base plate and reinforcement

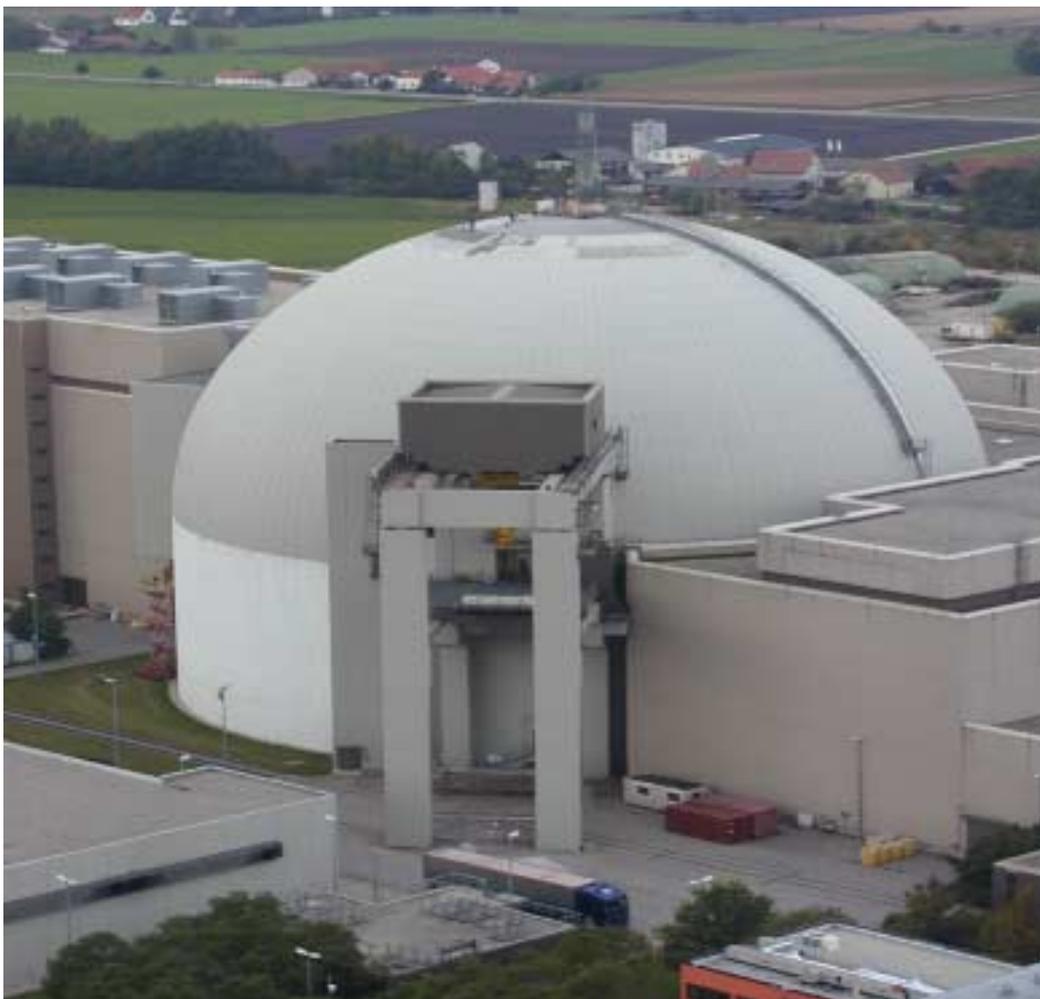
Picture 1: Total view of a safety compartment whilst reconstruction

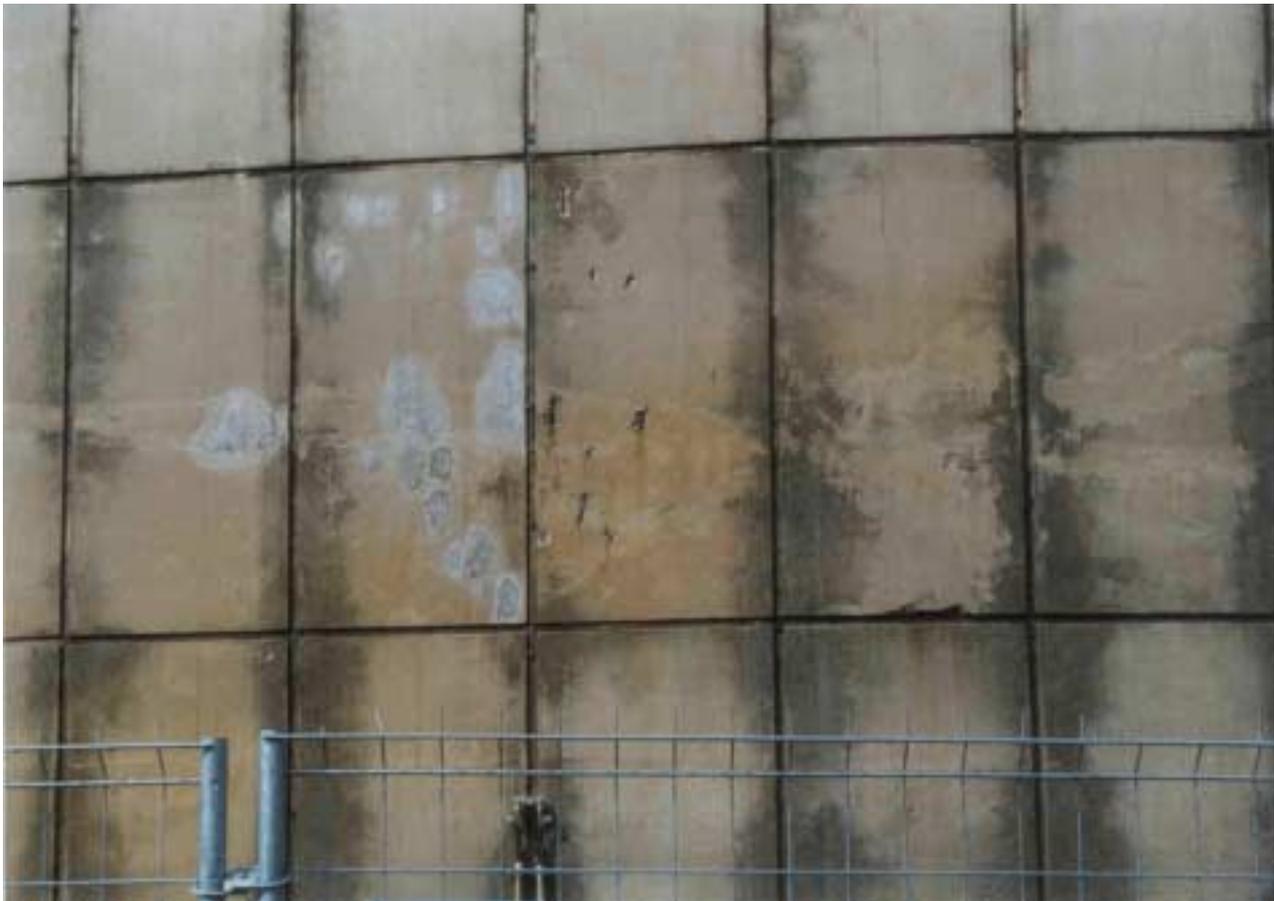
Picture 2: Concrete surface of a safety compartment with damages and deteriorations

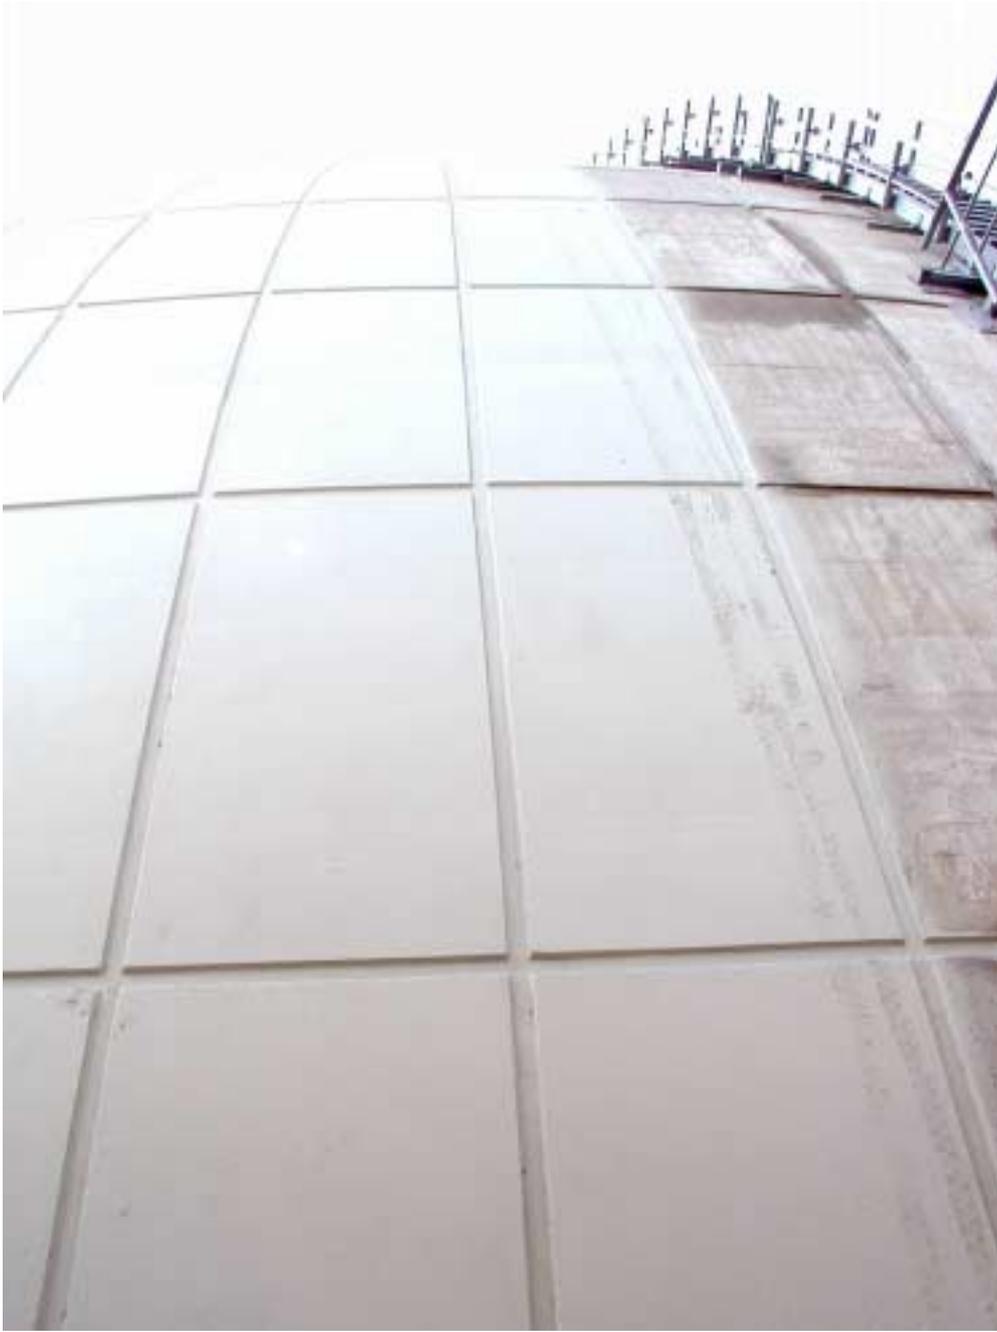
Picture 4: Dome with fluting structures

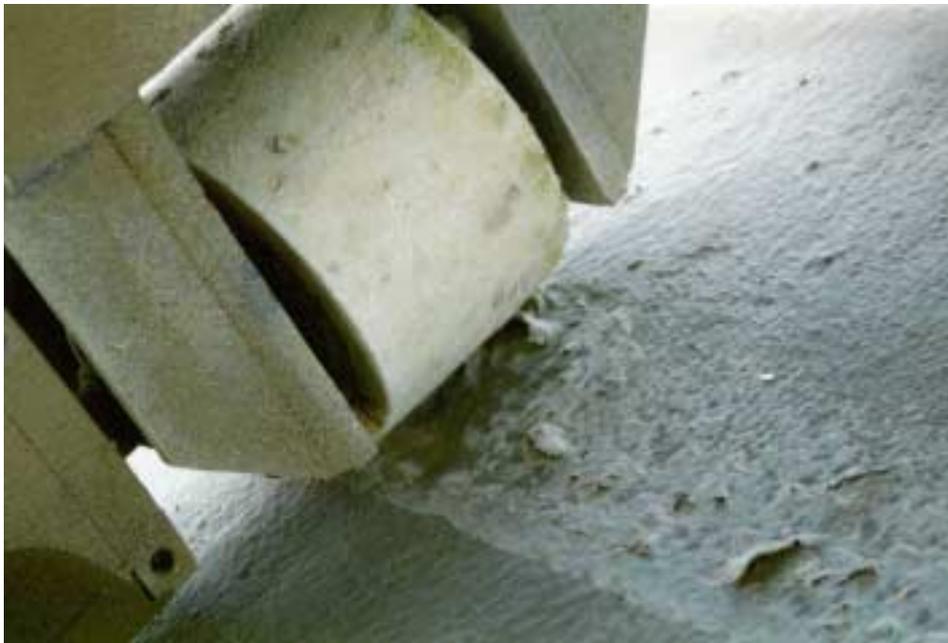
Picture 5: Damages on the repair system caused by high load on scaffolding wheels

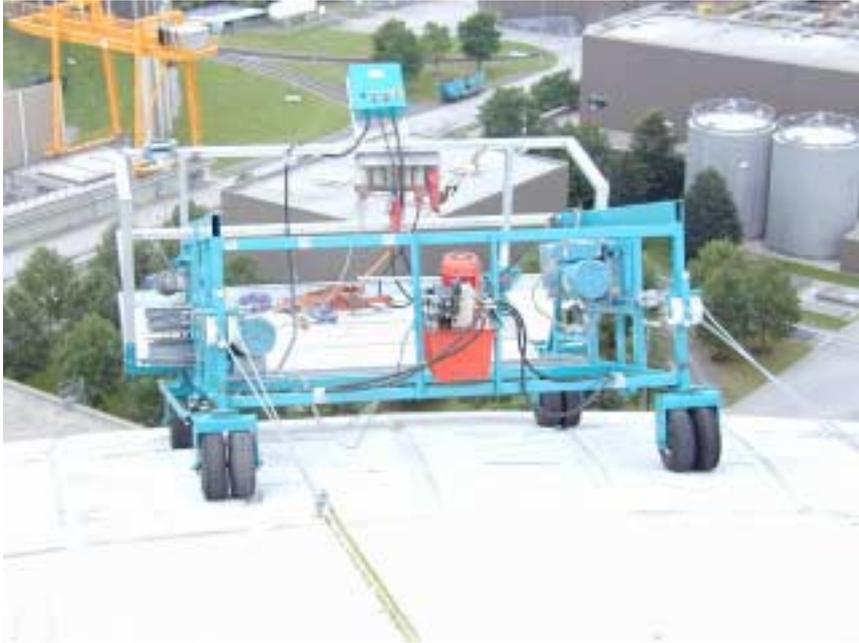
Picture 6: **New designed light weight scaffolding/platform**

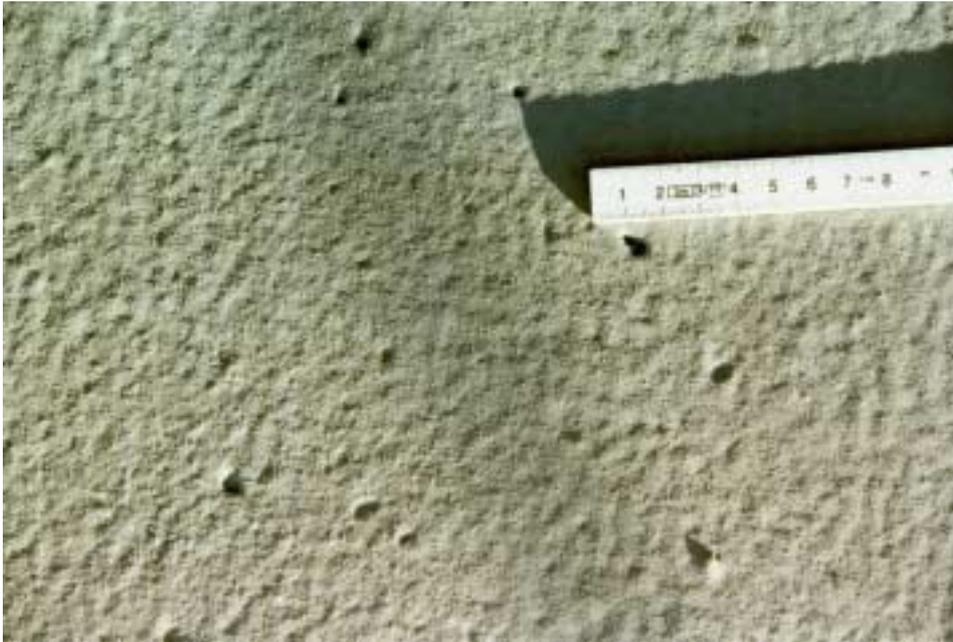
Picture 7: Surface of the crack – overbridging material with pores and hollows

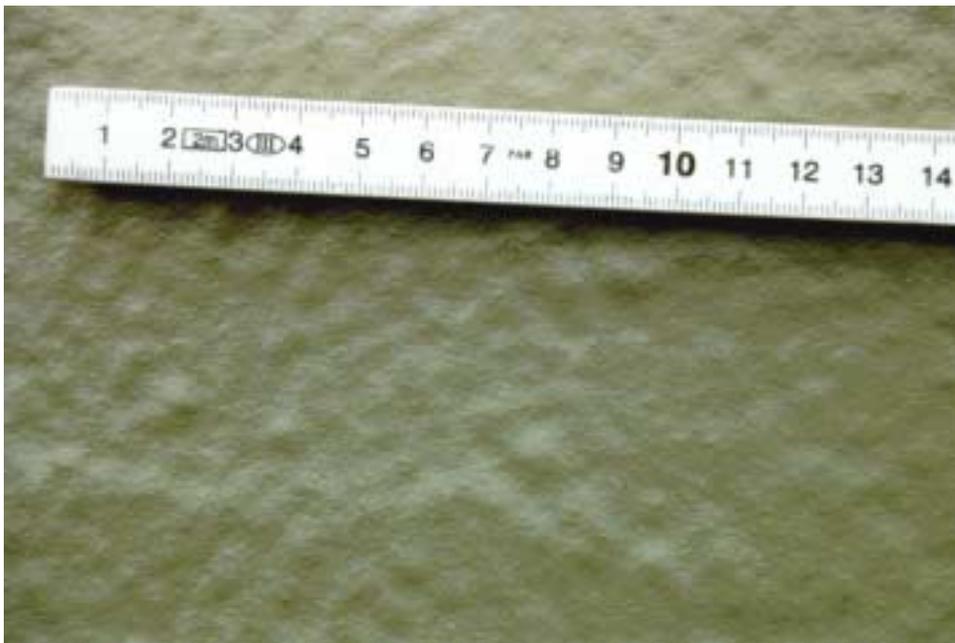
Picture 8: Perfect surface of the crack overbridging surface protection system

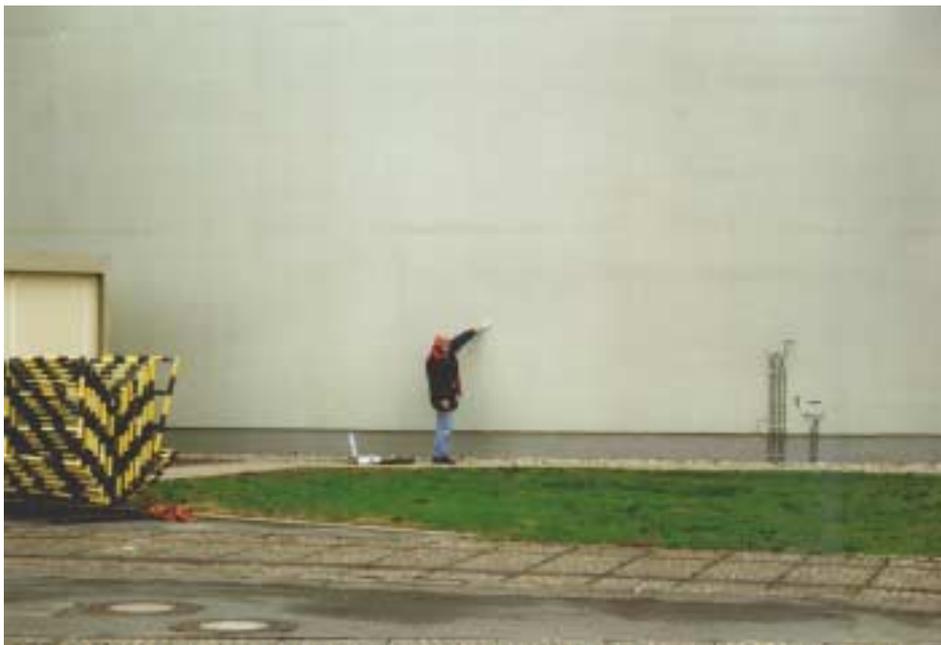
Picture 9: **Partial View of a restored concrete surface of a safety compartment**

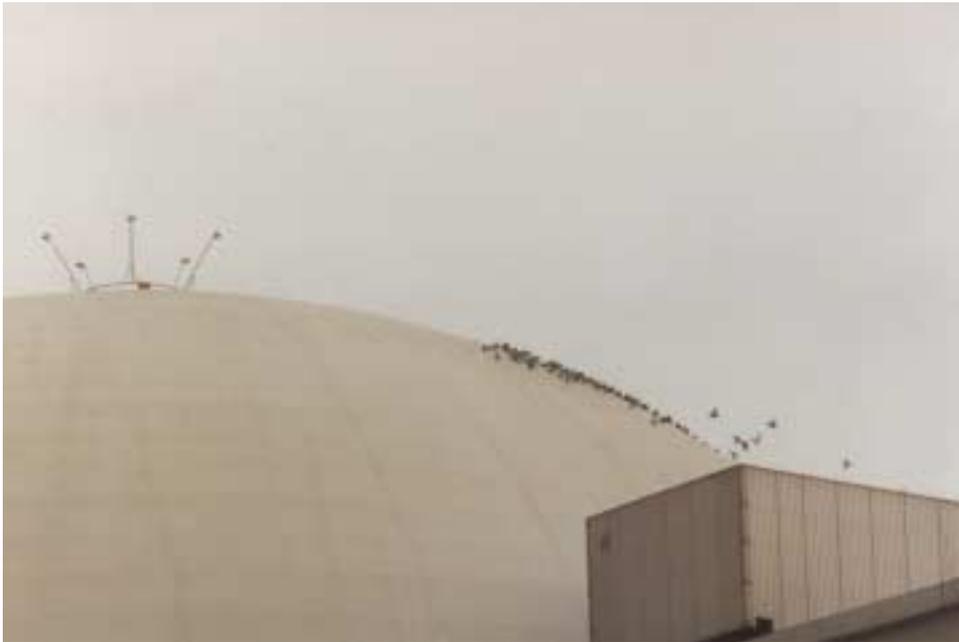
Picture 10: Completely restored surface, biological attack caused by birds residues
