First Construction Experience Synthesis Report 2008–2011

Working Group on the Regulation
of New Reactors (WGRNR)

NEA/CNRA/R(2012)2

**First Construction Experience Synthesis Report
2008-2011**

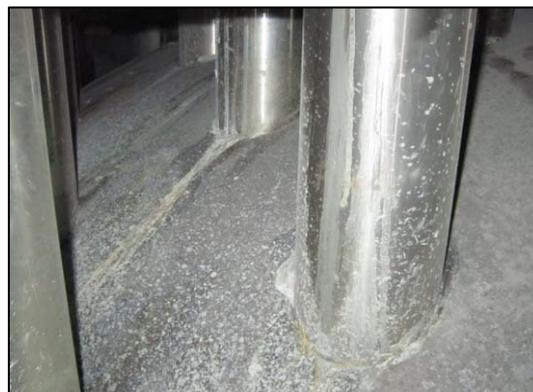
Reactor Vessel Head

In summary, although almost all of the SSCs within the containment were affected by the sprayed borated water, their integrity including functions after recovery was confirmed based on the results of inspections and evaluations in detail.
