**NEA/CSNI/R(2002)7/VOL1**

**OECD-NEA WORKSHOP ON THE EVALUATION OF DEFECTS,  
REPAIR CRITERIA & METHODS OF REPAIR FOR CONCRETE  
STRUCTURES ON NUCLEAR POWER PLANTS**

**Hosted by GRS at the DIN Institute in Berlin, Germany**

**10th-11th April, 2002**

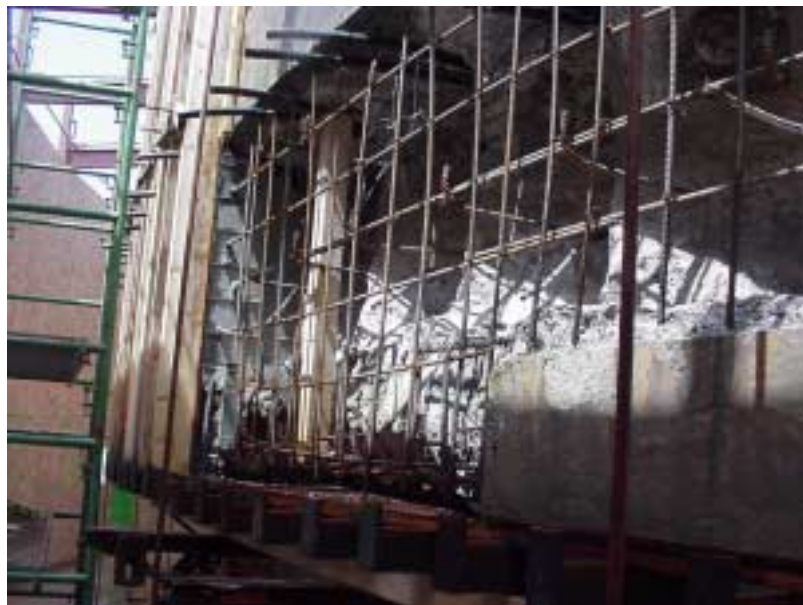
**Figure 7: Installation of Skin Reinforcement**

After the demolition, and prior to the grouting/concreting, skin reinforcement was installed, Figure 7. Surface preparation by hydro-jetting or sand blasting was employed to open the pore structure of the concrete surface and to remove dirt and other debris material, Figure 8.

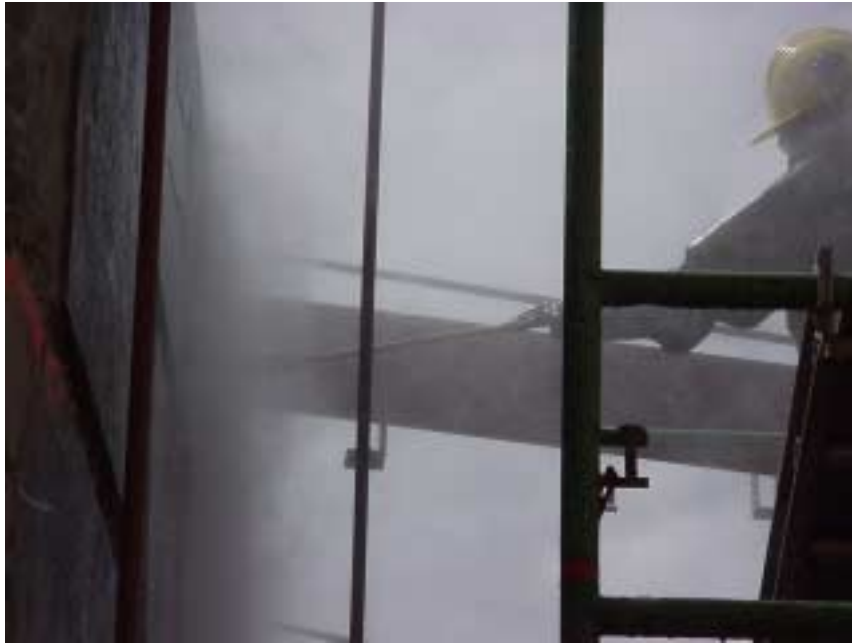
**Figure 8: Surface Preparation –Hydro-Jetting**

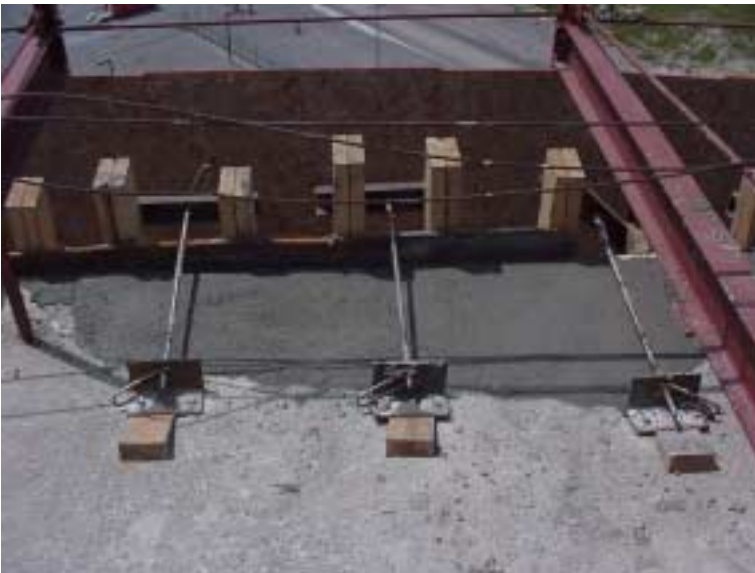
**Figure 10: Deep Repair – Completed**

The deep patches are repaired with Sika Grout 212, SikaCem 810, PeaGravel (5-9 mm) and water. The patches are formed, the concrete mix is poured and vibrated while being placed in the forms as shown in Figures 9 and 10.

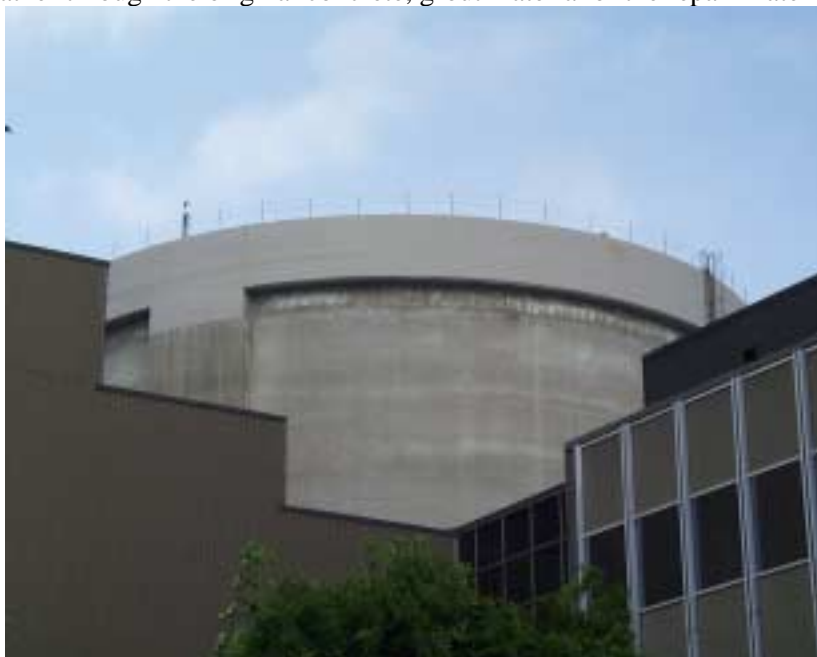
**Figure 13: Completed Repair South-West View**

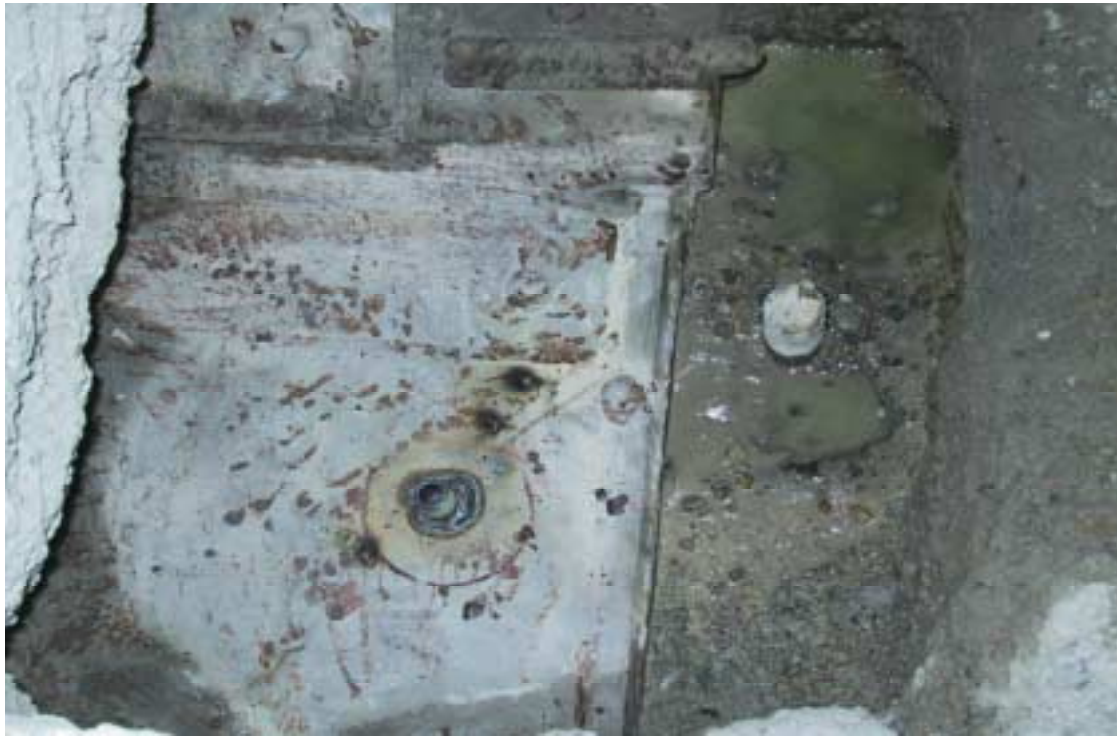
Injektion point No 1./19 with injection cap
