**NEA/CSNI/R(2002)7/VOL1**

**OECD-NEA WORKSHOP ON THE EVALUATION OF DEFECTS,  
REPAIR CRITERIA & METHODS OF REPAIR FOR CONCRETE  
STRUCTURES ON NUCLEAR POWER PLANTS**

**Hosted by GRS at the DIN Institute in Berlin, Germany**

**10th-11th April, 2002**

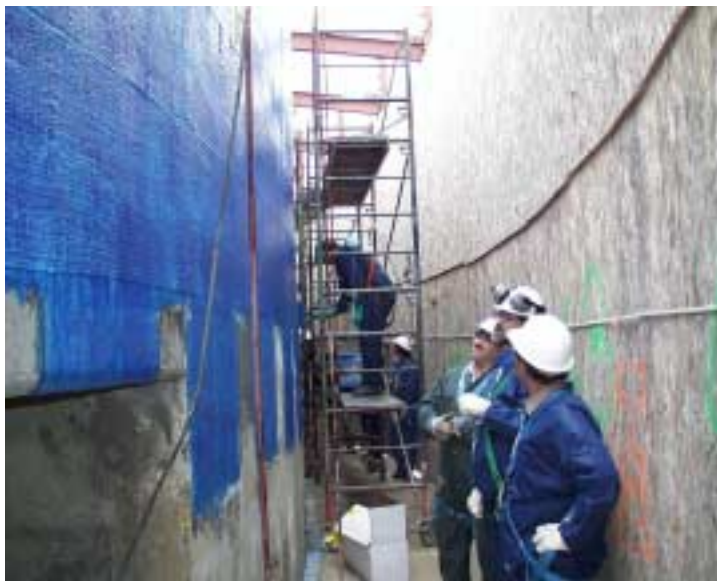
**Figure 11: GFRP Installation**

For this application, the MBrace (Master Builder Technologies) Composite Strengthening System was chosen. Its function is primarily to protect and ensure durability of the concrete repairs. The structural strength and high modulus of elasticity were not critical requirements. Based on the material properties, E-glass fiber (EG-900) fabric was the selected material since it exhibited the best flexibility and elasticity of the system for this application.

Site application of the GFRP to the ring beam is shown in Figure 11.

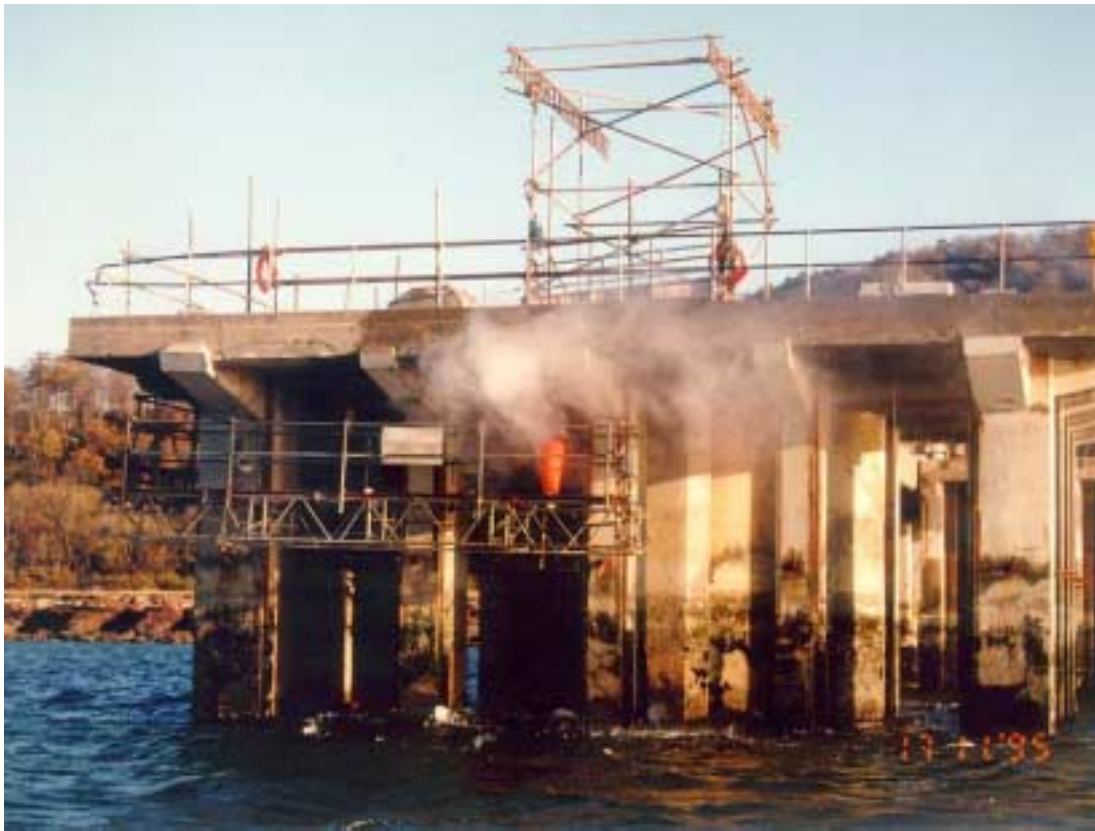
**Plate 1 Water jetting**

Existing previous repairs to the deck slab soffit, including secondary steel mesh reinforcement, were removed and the surface was profiled to maintain a minimum of 30 mm cover to the main reinforcement, which was repaired as required. The sequence of removal and reinstatement operations (A through E) is shown in Figure 4. High pressure water jetting was used to remove the concrete and patch repairs (Plates 1 & 2). Where required, existing reinforcing bars that were excessively corroded were supplemented and/or replaced with new steel suitably anchored into the structure. Once the entire deck slab soffit had been reprofiled and prepared a titanium anode mesh and anode ribbons were fixed and a sprayed concrete overlay applied (Figures 5 & 6).

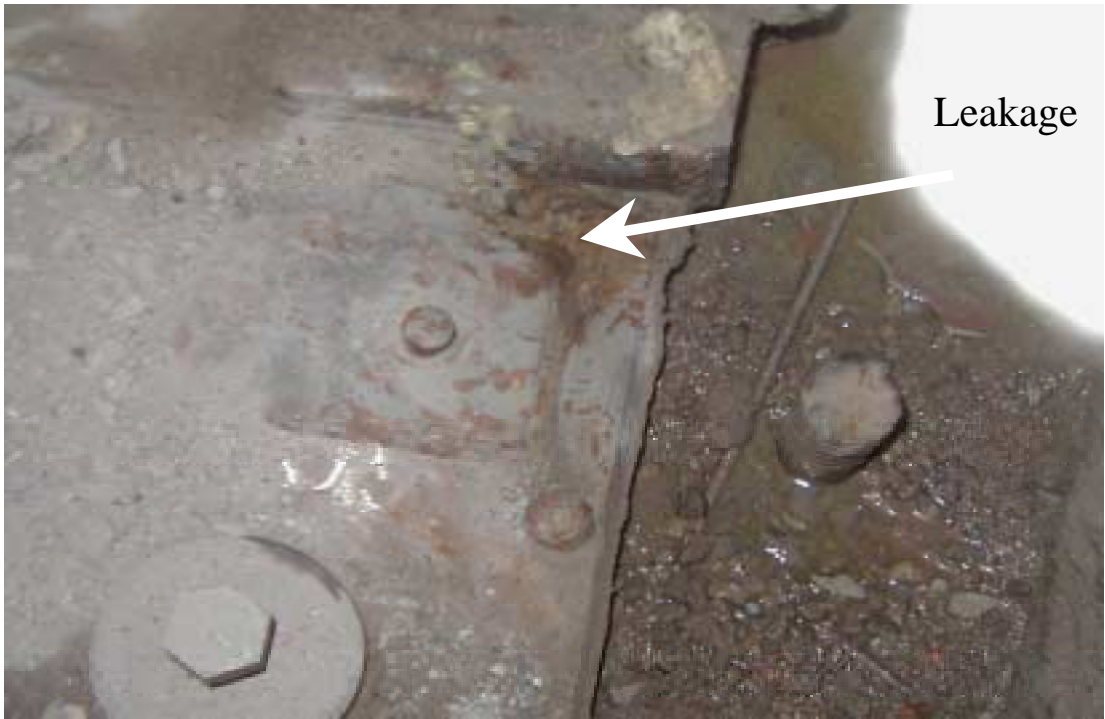
Injektion point No 1./19 with local control cap

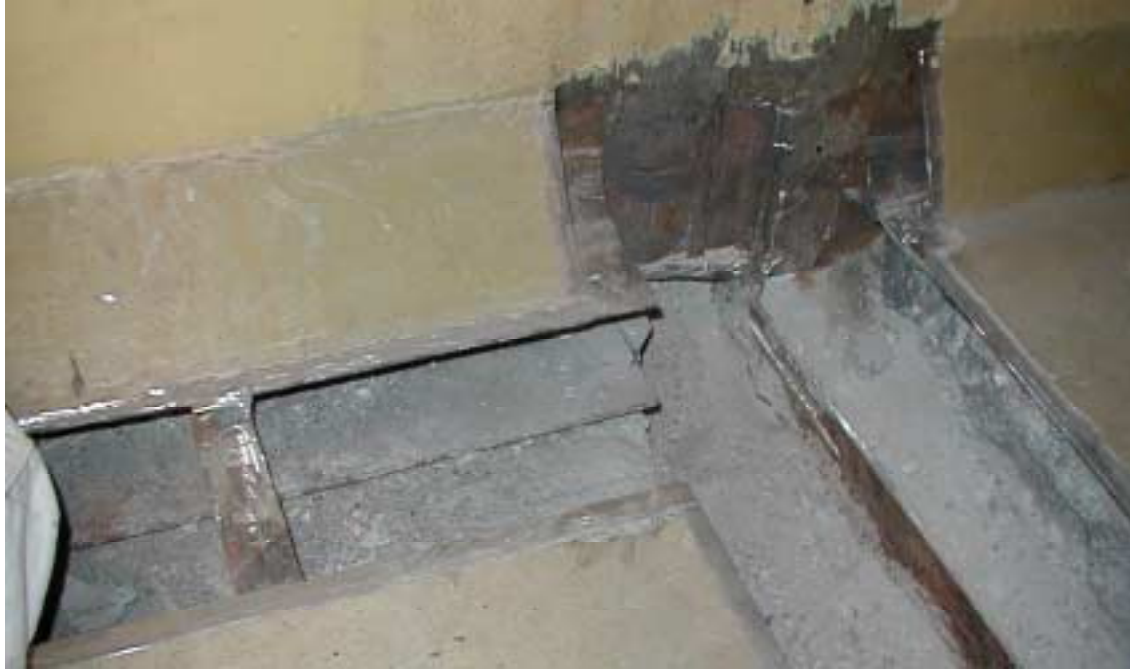
## Repaired connection in room A306/1

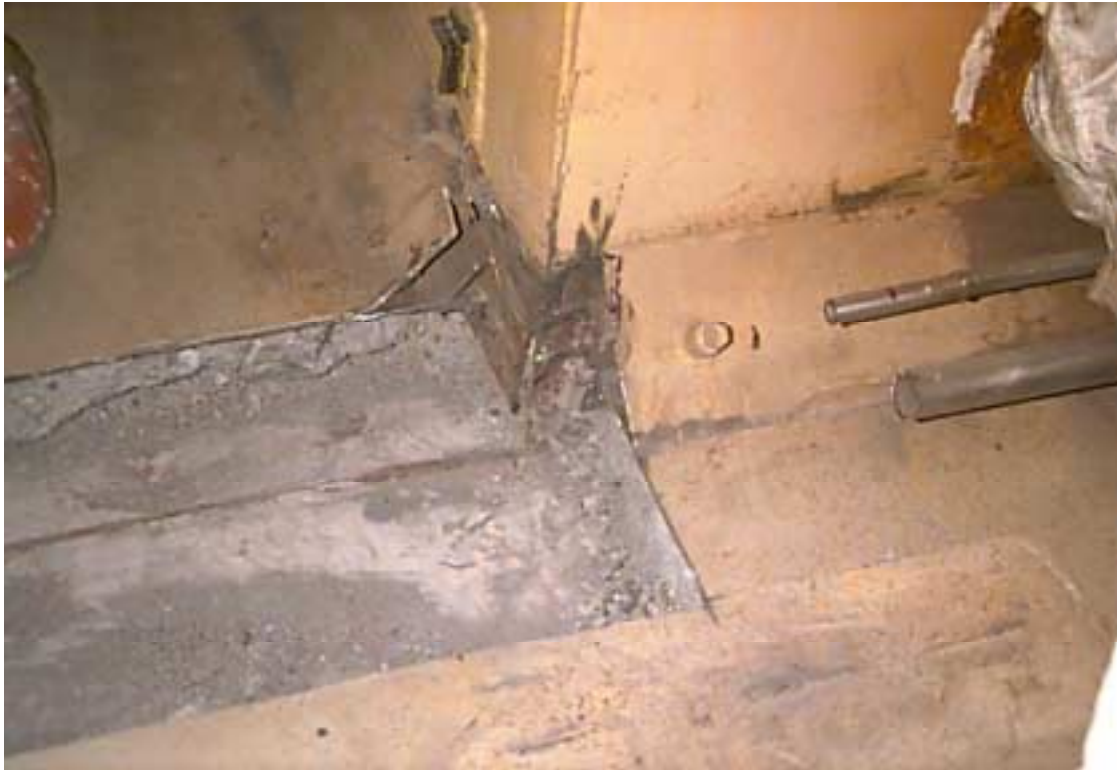
Repaired connection in room A306/1

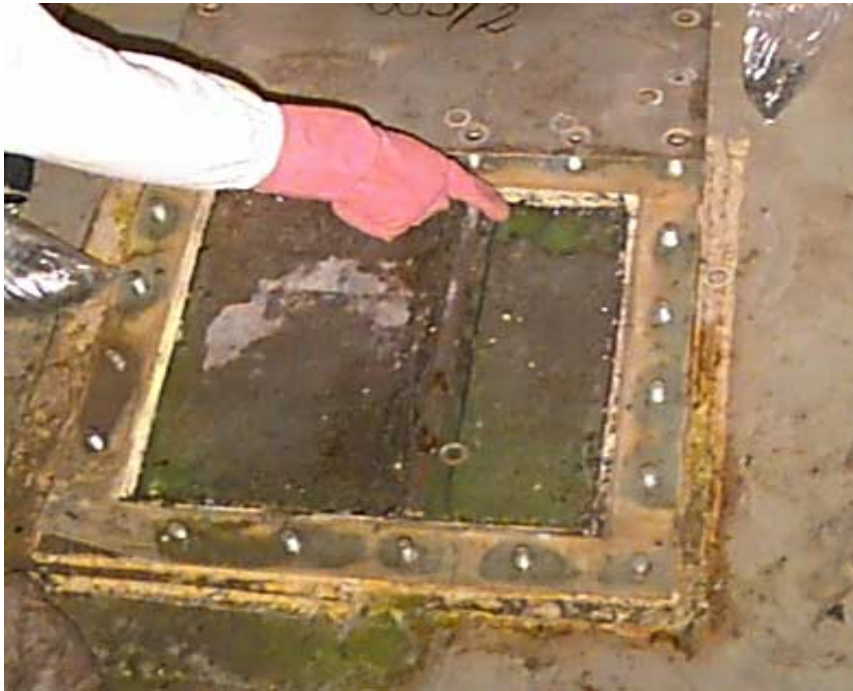
## Checking hole No3. for borical leakage and concrete at unit 2

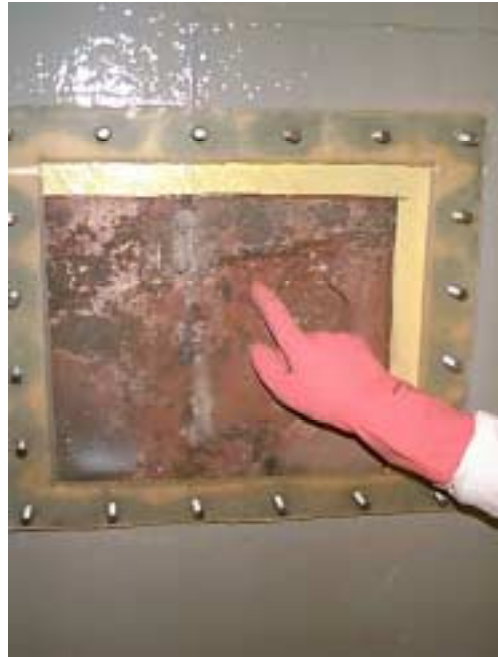
Checking hole No1. for borical leakage and concrete at unit 3

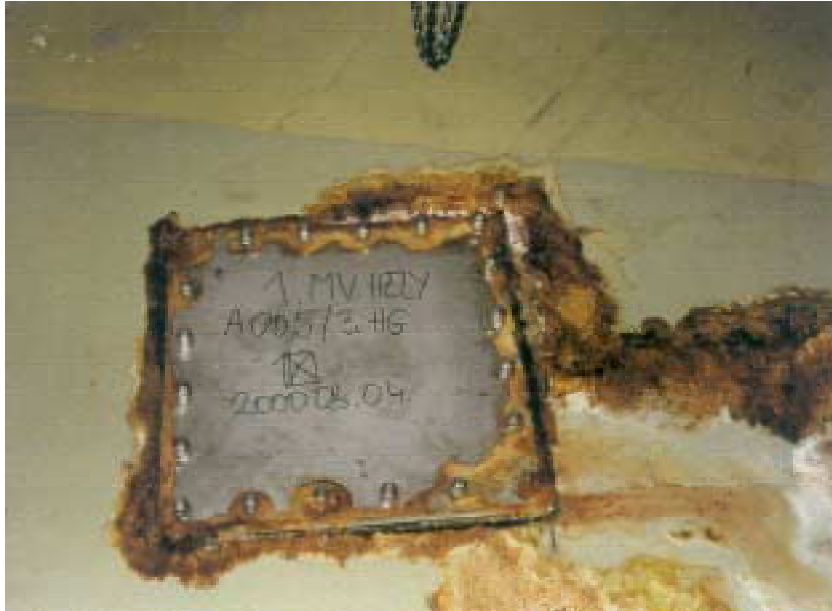
### Checking hole No2. for borical leakage and concrete at unit 3

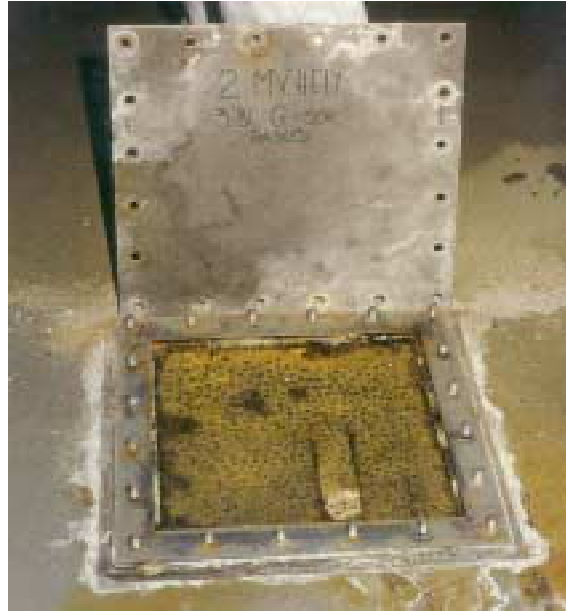
### Checking hole No 3. - unit 3
